Home Inspection Report for:

Mike Leonard -- Mike Leonard Home Inspections LLC
8 Highland Ave, Maplewood, NJ 07040
Home Inspector License #24GI00196100
973-801-0900 LeonardMG@gmail.com

November 3, 2023

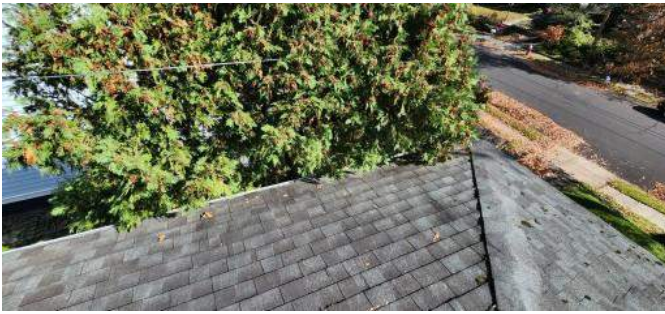
It was observed at the time of inspection that a tree branch(es) were hanging over the porch roof. Branches over the roof fill the gutters with leaves and debris. Branches can also cause damage to the roof shingles and house siding. Recommend trimming. It is suggested that a Licensed Tree Service be contacted for further review.

Trees touching the porch roof.

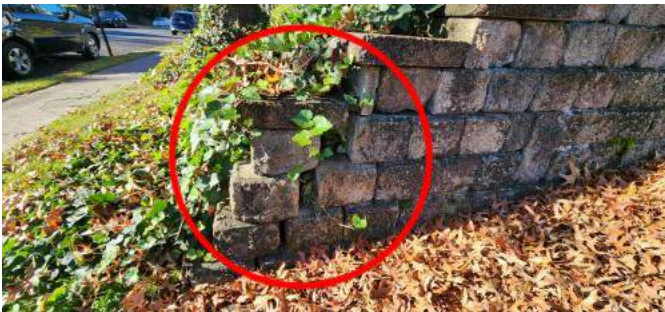
Right side of house.

There were 3 concrete paver retaining walls at the time of inspection (left, right, rear). All 3 walls were straight with no lean. They appeared to be in serviceable condition. It was observed there were some loose pavers at the left and right front walls. This is an indication that some movement has occurred. Recommend repair to avoid further deterioration. It is suggested that a Licensed Masonry Contractor be contacted for further evaluation and repair.

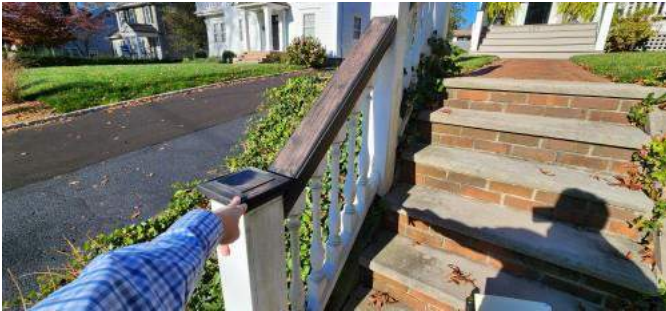
It was observed at the time of inspection that the handrail at the lower stairs was very loose. Recommend repair.

Loose handrail.

It is suggested that a Licensed Contractor be contacted for further evaluation and repair.

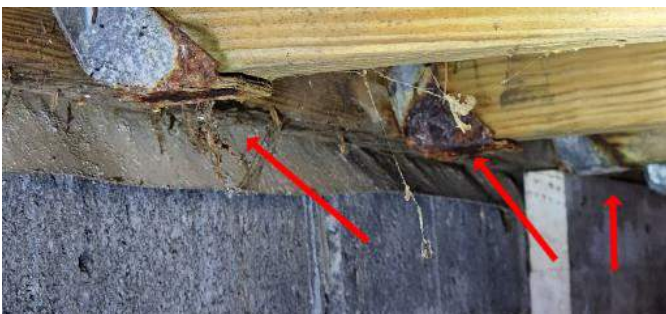
3 or more rusted joist hangers were observed under the rear deck and stairs. These joist hangers are structural supports. Recommend further evaluation and repair. There did not appear to be any flashing above the ledger board. Flashing is a piece of metal that is designed to keep water from getting behind the ledger board. It is suggested that a Licensed Contractor or Qualified Handyman be contacted for further evaluation and repair.

Rusted joist hangers.

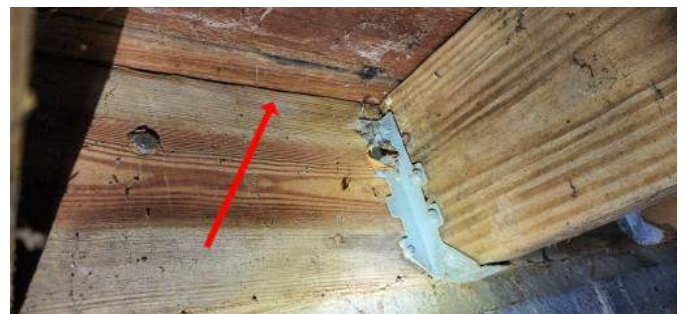
No flashing visible.

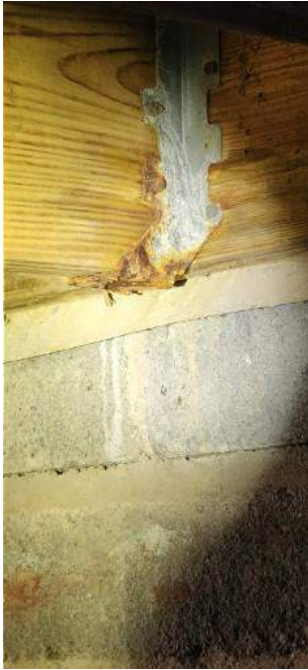
Rusted joist hanger.

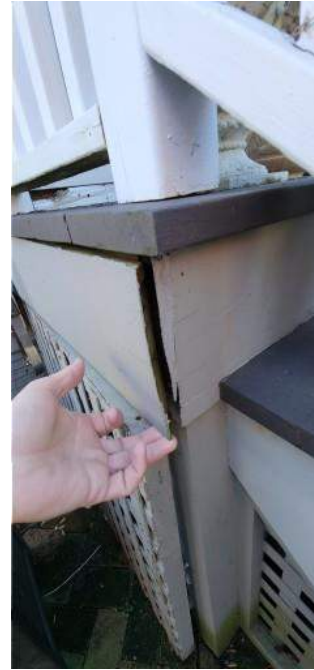
Trim board not attached.

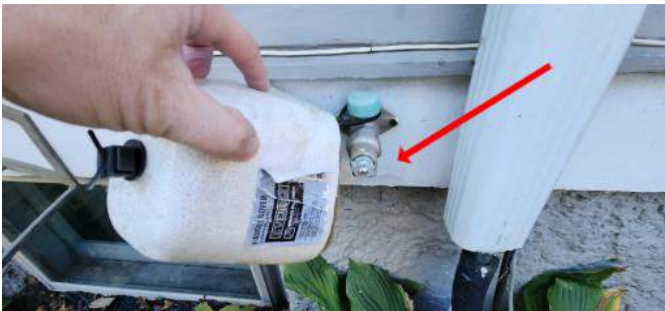
It was observed that the faucet handle on the right side of the house was broken off. Recommend repair. It is suggested that a Qualified Handyman be contacted for further evaluation and repair.

Faucet handle broken off.

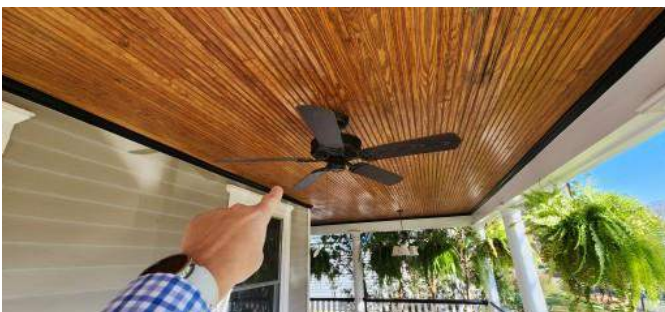
At the time of inspection the ceiling fan on the front porch was not functional. Recommend repair or replacement. It is suggested that a Licensed Electrical Contractor be contacted for further evaluation and repair.

Ceiling fan was not operational.

It is suggested that a Licensed Electrical Contractor be contacted for further evaluation and repair.

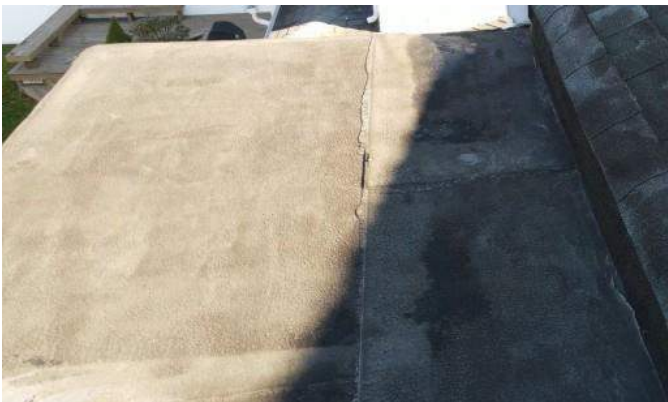
At the time of inspection, extensive alligatoring was observed on the flat roof at the rear of the house. Roof alligatoring is a phenomenon that occurs as a flat roof ages. In general, it's caused by the sun. The bright UV rays eventually dry out the membrane or coating that tops your flat roof, causing it to crack. The older your roof gets, and the longer you leave alligatoring to its own devices, the worse it will get. Extreme temperature changes, from sunlight, snow, and even internal heating and cooling will cause new cracks to appear and will make existing cracks worse. Recommend further evaluation and repair by a Licensed Roofing Contractor.

Flat roof is cracking and likely at the end of its life.

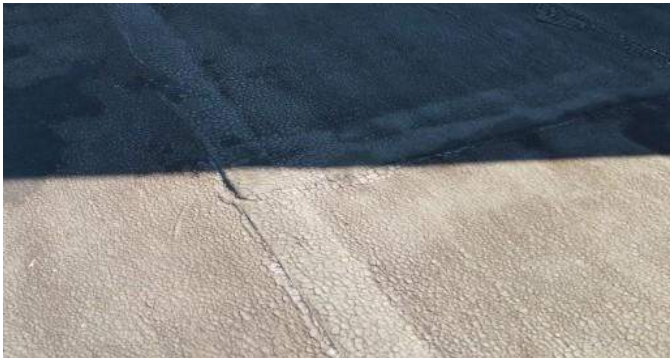
Alligatoring.

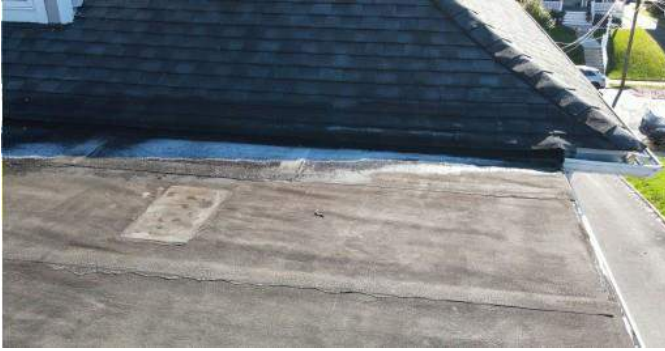
Flat roof is cracking.

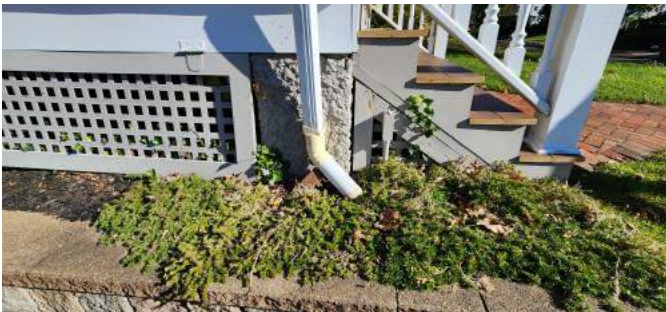
Downspout empties into underground drain.

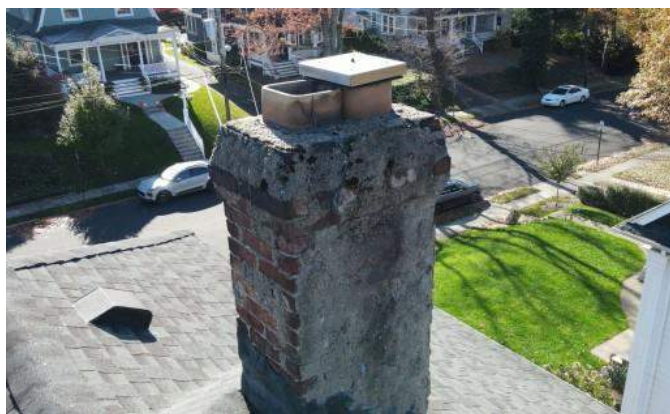
The brick chimney was in poor condition at the time of inspection. Significant cracking was observed. The chimney crown was not sealed. The flue appeared to be cracked. There was a missing rain cap. The tar covering the flashing was dry and cracked. It is suggested that a Licensed Chimney Contractor be contacted for further evaluation and repair.

Chimney was in poor condition.

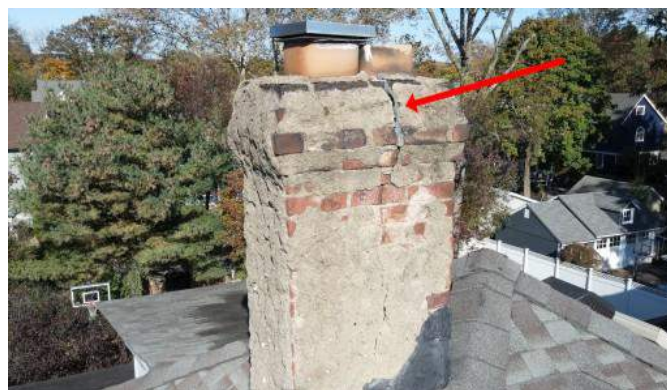
Major cracks and deterioration.

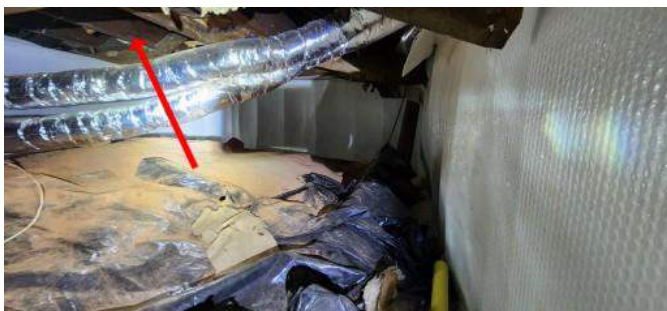
Interior: It was observed that some insulation in the joists had fallen out of place. Recommend securing the insulation and installing new insulation where needed. It is suggested that a Licensed Contractor be contacted for further evaluation and repair.

Missing insulation.

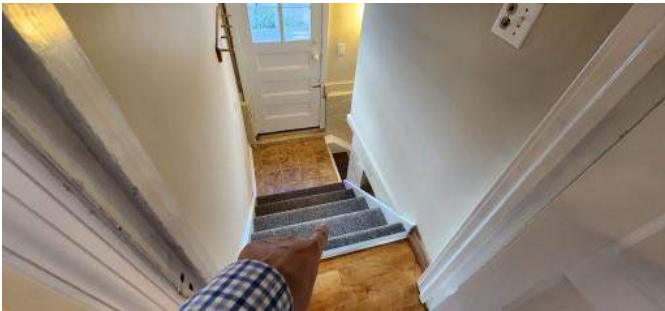
There was no handrail present at the basement stairs at the time of inspection. Recommend installing one for safety. It is suggested that a Qualified Handyman be contacted for further evaluation and repair.

No handrail at basement stairs.

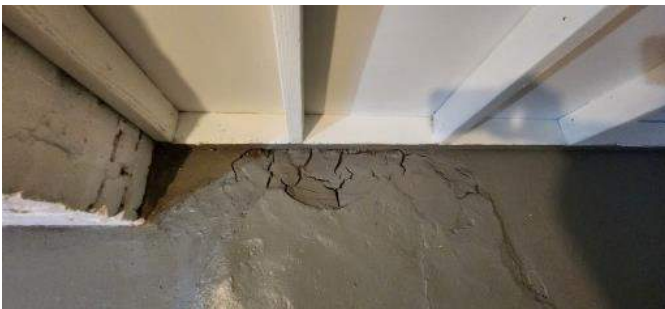
The general condition of the visible and accessible portions of the floors appeared to be in serviceable condition at the time of the inspection. In the finished area of the basement the floor was carpet covered. A small area in front of the boiler was cracked. The floor is not a structural element. Repair as needed.

Cracked floor.

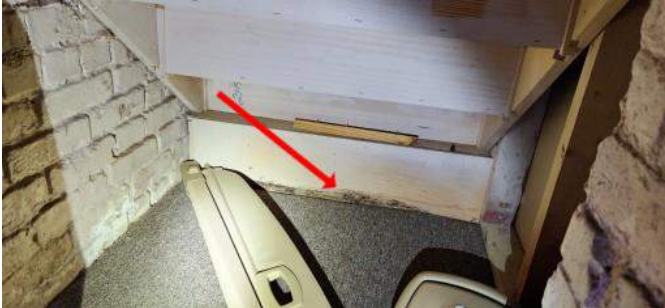
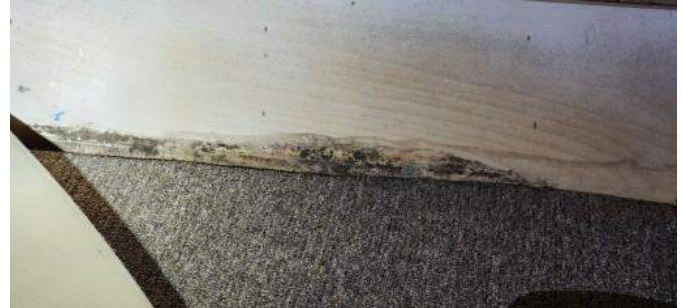
A mold-like substance was observed in the closet under the basement stairs. The only way to identify mold is through lab testing. It is recommended that a Licensed Mold Contractor be contacted for testing and, if necessary, removal.

Mold-like substance.

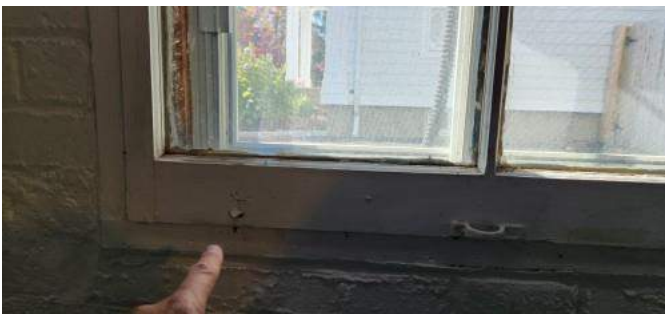
At the time of inspection it was observed that some of the windows were nailed shut. It recommended that the nails be removed so the windows open in case of emergency. The window at the basement stairs would not open. It is suggested that a Qualified Handyman be contacted for further evaluation and repair.

Nailed shut.

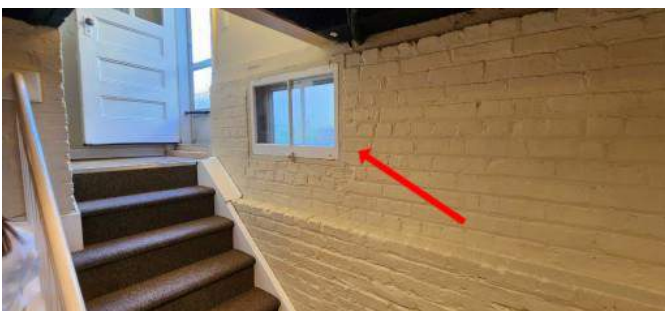
Window would not open.

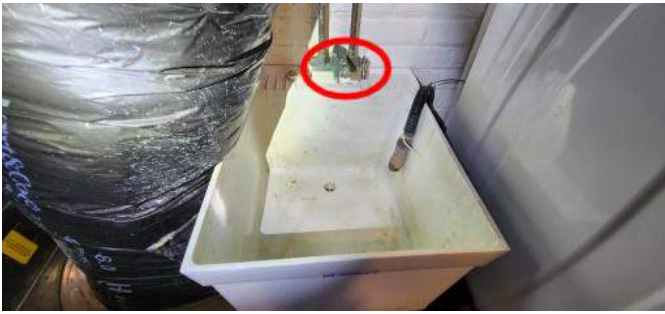
It was observed that the faucet at the sink dripped when it was shut off. Repair as needed. It is suggested that a Licensed Plumbing Contractor be contacted for further evaluation and repair.

Dripped.

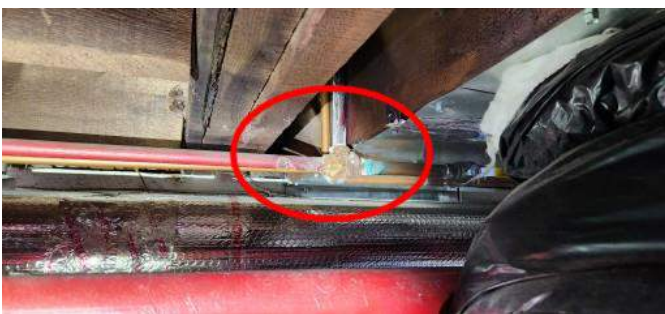
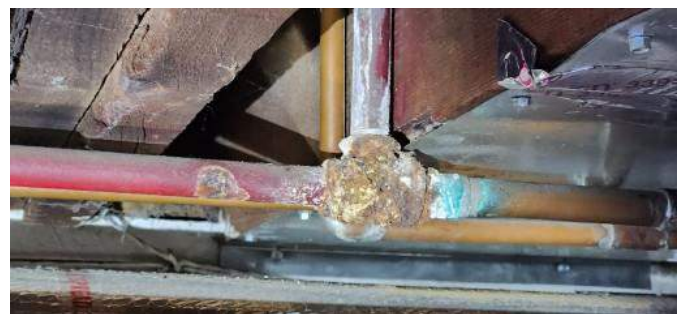
Galvanized piping was observed. Although this type of piping was commonly used in older homes, galvanized piping is no longer used in today's construction. Galvanized piping has a tendency to rust from the inside. This condition can reduce the water flow and pressure. At the time of inspection there were 3 galvanized pipes that showed indications that they have been leaking. These areas are badly corroded and mineral deposits were observed. It is necessary for these areas to be repaired immediately. It is suggested that a Licensed Plumbing Contractor be contacted for further evaluation and repair.

Pipe has been leaking here. (right of washer/dryer)

Closer look.

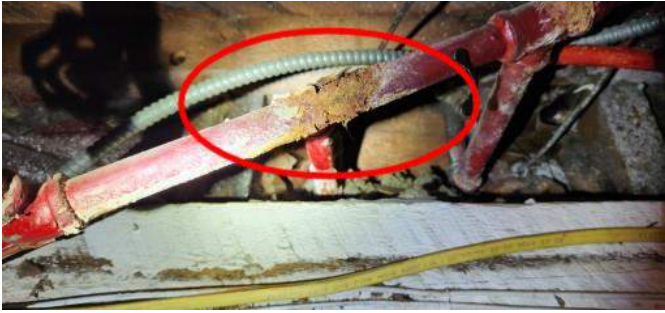
Corrosion and leaking. (back left of basement)

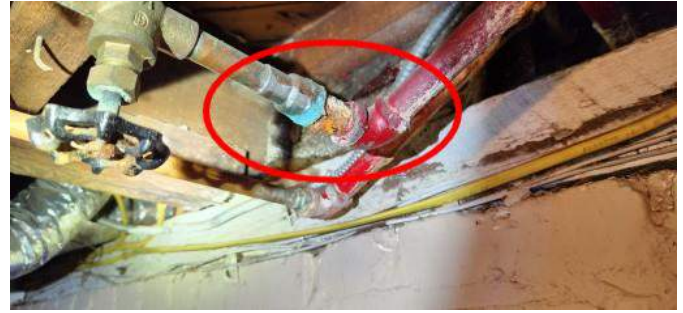
Indications of a leak. (back left of basement)

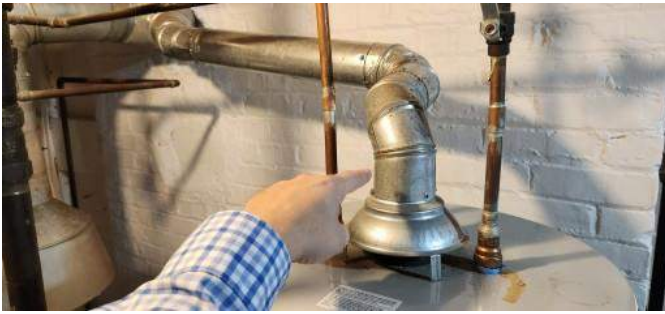
It was observed at the time of inspection that the flue for the water heater was the wrong size. A 4" pipe is required to properly vent carbon monoxide. It is suggested that a Licensed Plumbing Contractor be contacted for further evaluation and repair.

Should be a 4" vent. (3" is present)

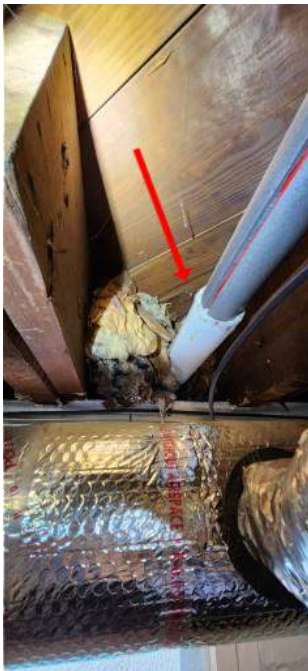
Rear of basement, driveway side.

Material similar to the insulation present has been known to contain asbestos. Asbestos was commonly used in older heating systems. Determining the presence of asbestos can only be performed by laboratory testing and is beyond the scope of this inspection. It is recommended that a Licensed Asbestos Contractor be contacted for testing and removal.

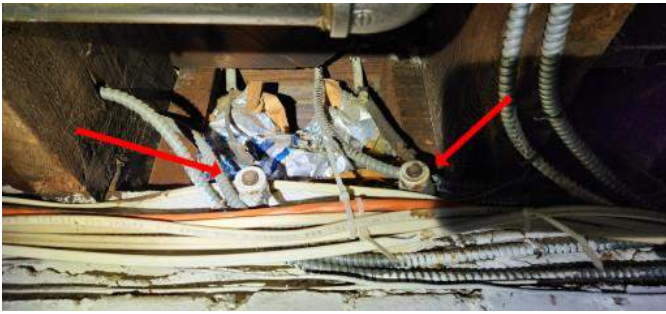
Knob and tube wiring was observed at the time of inspection. The accessible wires were tested with a voltage detector and were found to be live. There was approximately 30 feet of active wiring visible. Although installation and usage of this wiring was typical at the time of installation, today's construction no longer uses this out dated system. Since this older wiring exists with open splices and limited wire insulation, client is advised to consult with a licensed electrician (prior to close) for further information on this wiring and / or upgrading. Client should also contact their insurer (prior to close) to inquire whether the presence of this wiring affects home insurance coverage. It is suggested that a Licensed Electrical Contractor be contacted for further evaluation and repair.

Knob and tube.

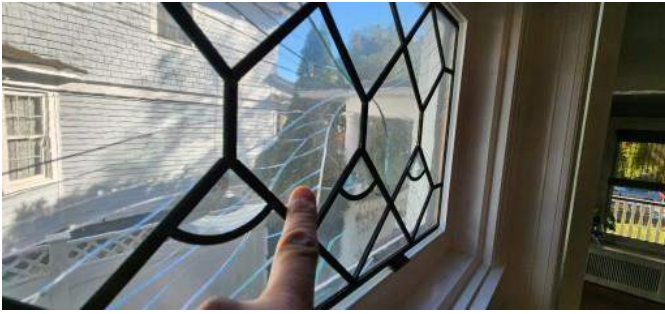
At the time of inspection a pane of glass at the stained glass window was broken. Recommend repair. It is suggested that a Licensed Contractor be contacted for further evaluation and repair.

Exterior window at the stained glass was broken.

suggested that a Licensed Contractor be contacted for further evaluation and repair.

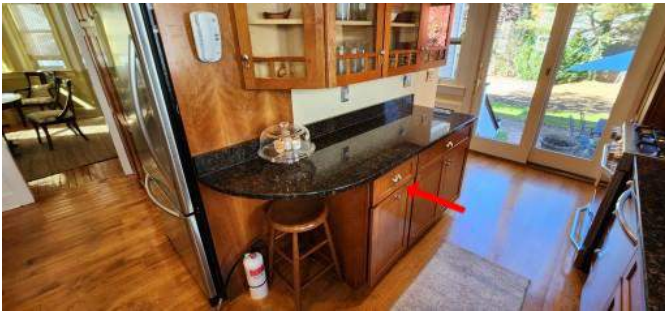
Drawer pull missing screw.

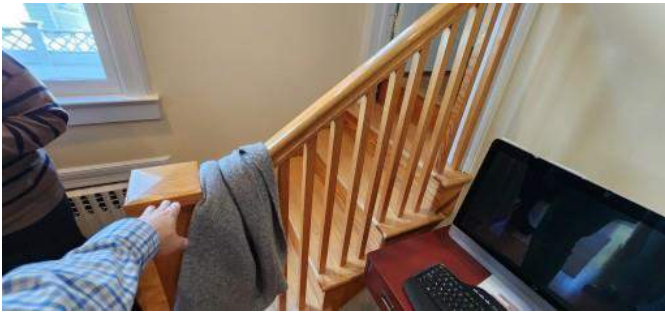
At the time of inspection the handrail at the interior stairs was loose in the kitchen. Recommend repair. It is suggested that a Qualified Handyman be contacted for further evaluation and repair.

Loose handrail in kitchen.

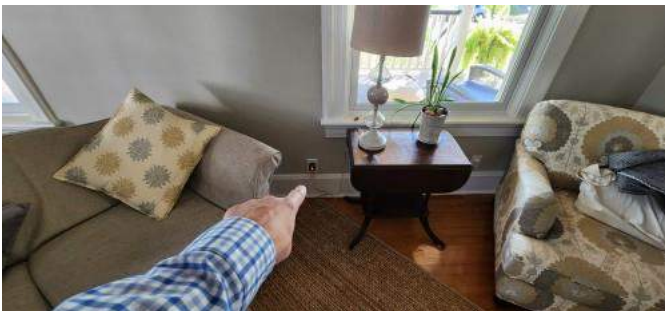
An outlet in the Living Room tested for an open/missing ground at the time of inspection. An open ground is when a three-pronged outlet is not connected to the home's grounding system. This is unsafe because if a fault were to happen, the surge could damage equipment or people rather than routing to the ground. This is a common wiring mistake that can usually be repaired at the outlet. It is recommend that a Licensed Electrical Contractor be contacted for further evaluation and repair.

Missing ground.

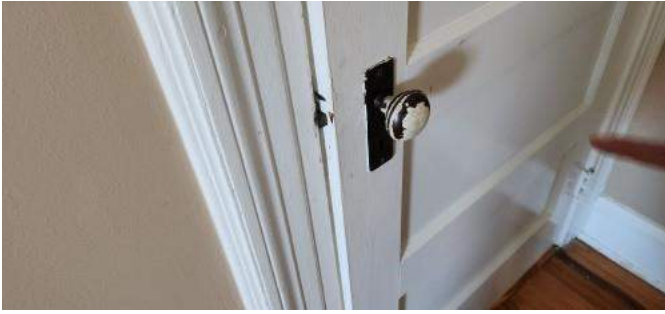
It was observed at the time of inspection that the bedroom door didn't latch properly at the time of inspection. Recommend repair/adjustment by a Qualified Handyman as needed.

Would not latch.

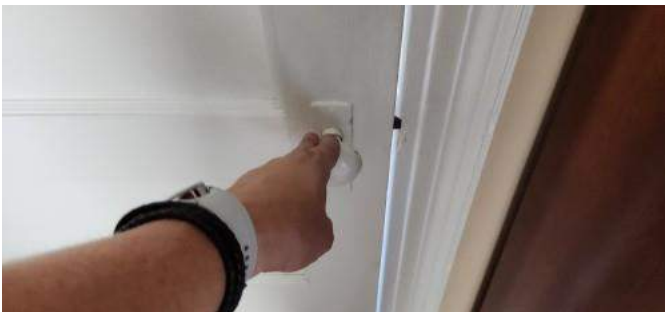
It was observed at the time of inspection that the bathroom door didn't latch properly at the time of inspection. Recommend repair/adjustment by a Qualified Handyman as needed.

Would not latch.

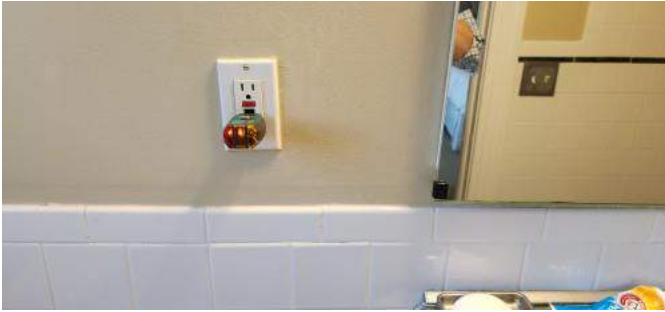
At the time of inspection an outlet in this room tested for reverse polarity. Reverse Polarity is when a receptacle is wired backward. This happens when the "hot" wire, also known as the black or red wire, is wired on the neutral side and the neutral wire is wired on the "hot" side. Devices plugged into the receptacle may "work" but it is unsafe and risks a short circuit, shock, or fire. Recommend further evaluation and repair by a Licensed Electrical Contractor.

Reversed polarity.

receptacle may "work" but it is unsafe and risks a short circuit, shock, or fire. Recommend further evaluation and repair by a Licensed Electrical Contractor.

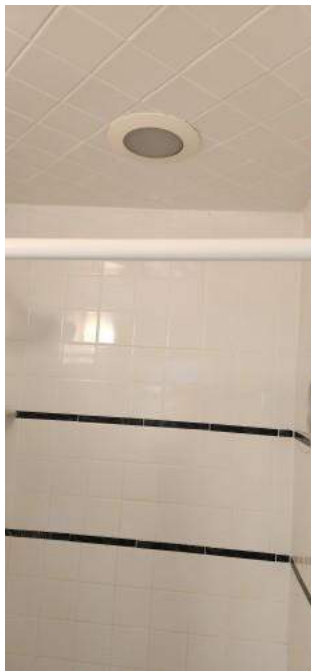
At the time of inspection a light in this room did not function. Recommend changing the bulb and re-testing. If the problem persists it is recommended a Licensed Electrical Contractor be contacted for further evaluation and repair.

Light in shower did not work.

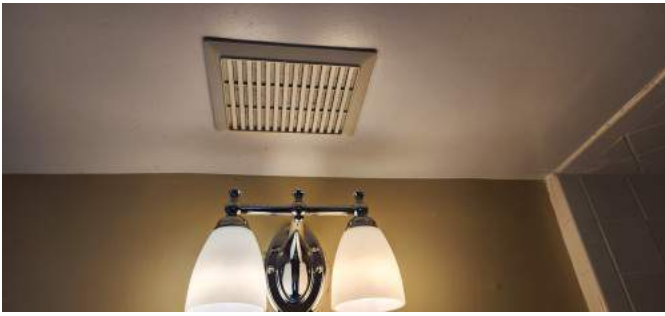
The exhaust fan made an unusual squeaking noise at the time of inspection. Recommend repair or replacement. It is suggested that a Licensed Electrical Contractor or Qualified Handyman be contacted for further evaluation and repair.

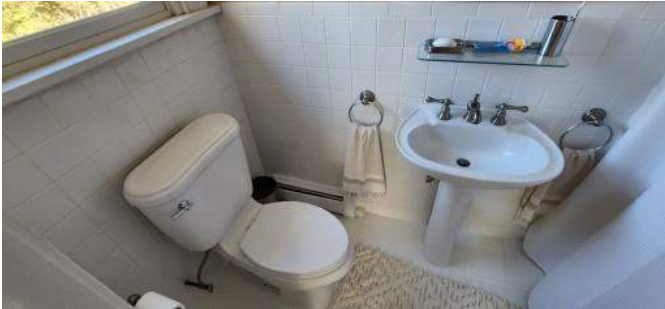
At the time of inspection the toilet did not flush completely. Recommend adjustment. It is suggested that a Licensed Plumbing Contractor be contacted for further evaluation and repair.

Toilet didn't completely flush.

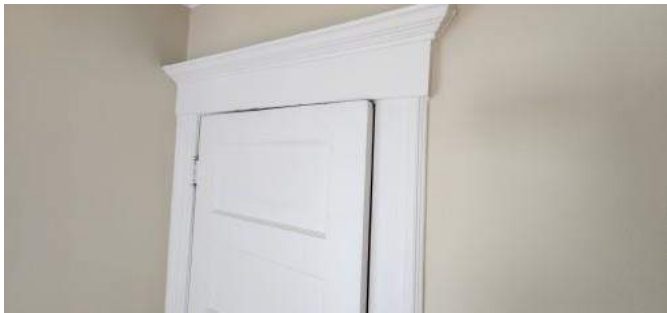
Closet door rubbed at frame.

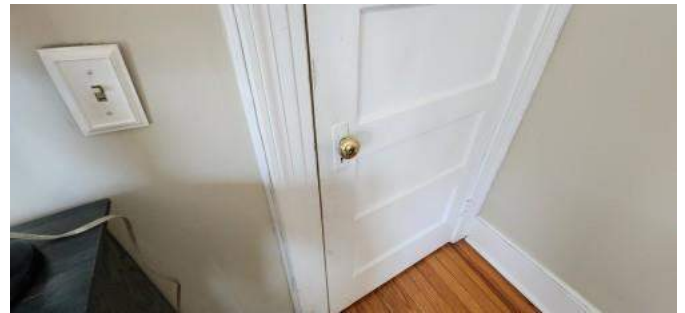
It was observed at the time of inspection that the bedroom door didn't latch properly at the time of inspection. Recommend repair/adjustment by a Qualified Handyman as needed.

Needs adjustment.

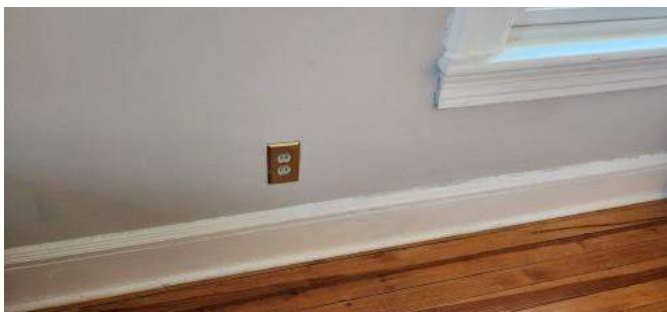
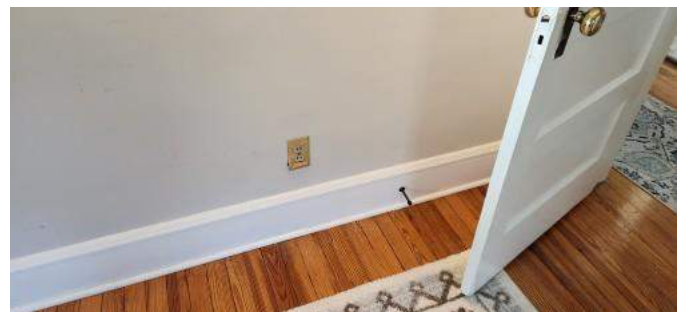
Two or more non-grounded (two prong) receptacles were observed at the time of inspection. Although these were commonly used years ago, we recommend a Licensed Electrical Contractor upgrade to grounded three prong receptacles.

2-prong outlet.

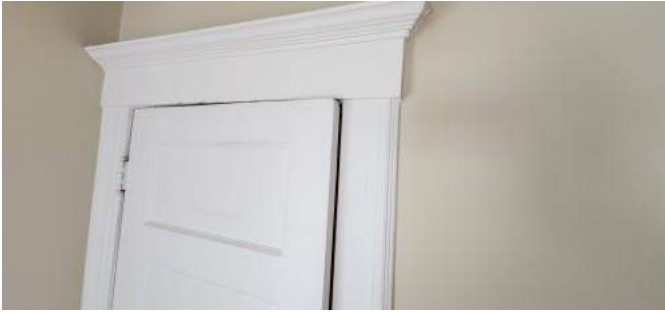
Closet door needs adjustment.

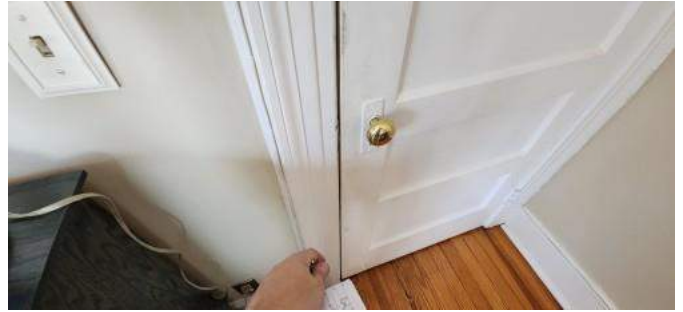
It was observed at the time of inspection that the bedroom door didn't latch properly at the time of inspection. Recommend repair/adjustment by a Qualified Handyman as needed.

Would not latch.

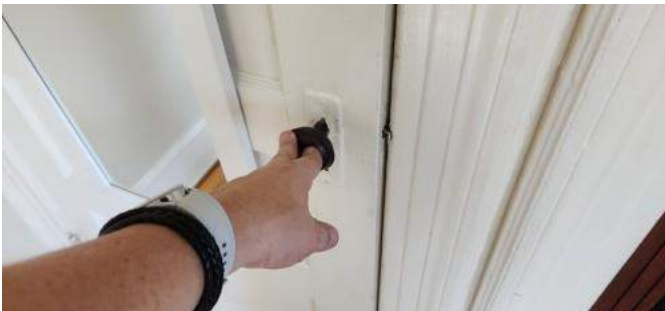
It was observed at the time of inspection that the bedroom door didn't latch properly at the time of inspection. Recommend repair/adjustment by a Qualified Handyman as needed.

Needs adjustment.

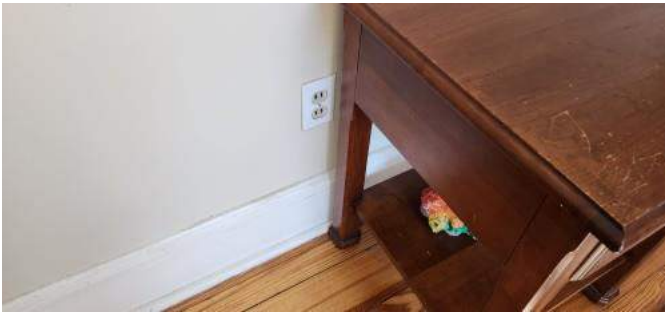
One or more non-grounded (two prong) receptacles were observed at the time of inspection. Although these were commonly used years ago, we recommend a Licensed Electrical Contractor upgrade to grounded three prong receptacles.

Ungrounded, 2-prong outlet.

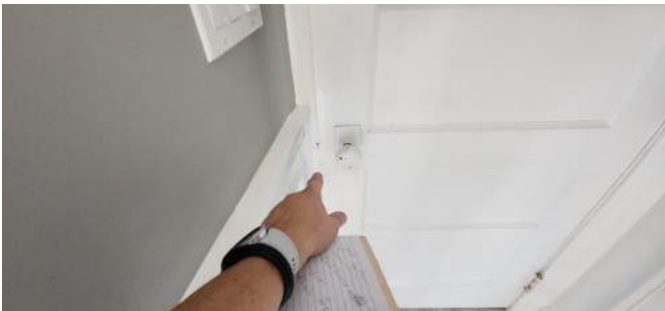
It was observed at the time of inspection that the bathroom door didn't latch properly at the time of inspection. Recommend repair/adjustment by a Qualified Handyman as needed.

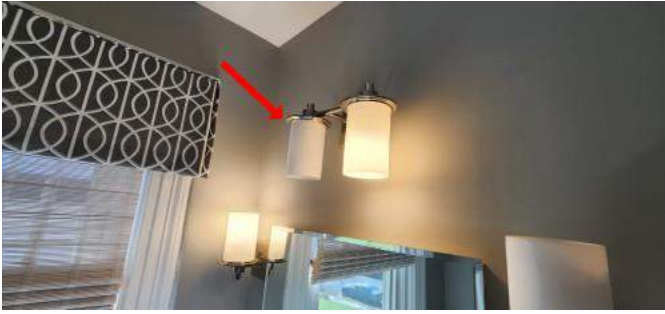
At the time of inspection a light in this room did not function. Recommend changing the bulb and re-testing. If necessary, it is recommended a Licensed Electrical Contractor be contacted for further evaluation and repair.

Recommend replacing bulb and retesting.

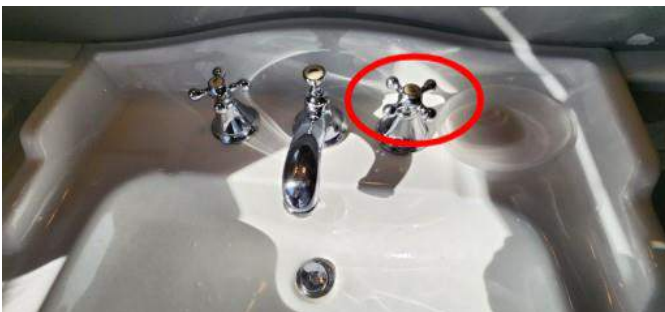
The cold water faucet was threaded backwards. This means it turns the wrong way. Repair as needed.

Threaded the wrong way.

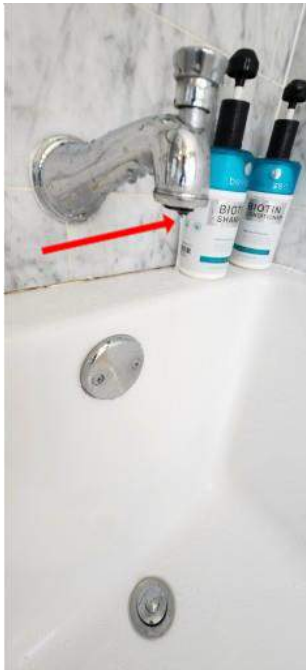
At the time of inspection the faucet continued to drip after the water was turned off. Recommend repair. It is suggested that a Licensed Plumbing Contractor be contacted for further evaluation and repair.

Water continued to run from the spout when water was off.

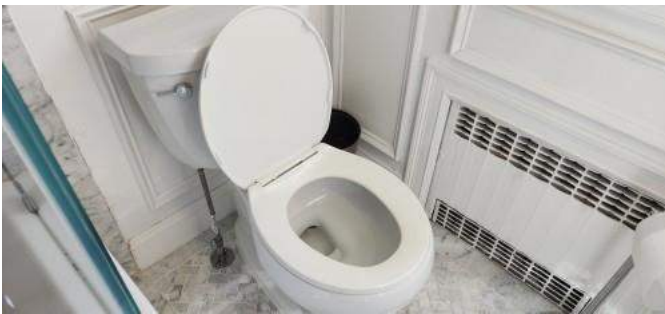
The toilet did not flush completely at the time of inspection. Recommend adjustment. It is suggested that a Licensed Plumbing Contractor be contacted for further evaluation and repair.

Needs adjustment.

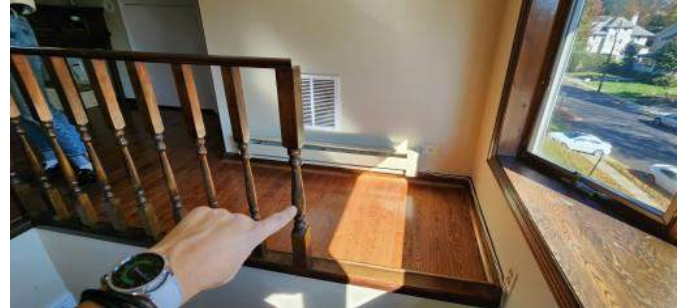
At the time of inspection it was observed that the guardrail around the stairs was loose. Part of the opening was unprotected with no guardrail. The gap between the balusters was wider than 4" which could allow a child to stick their head into the space. Recommend repair/replacement for safety.

Missing guardrail.

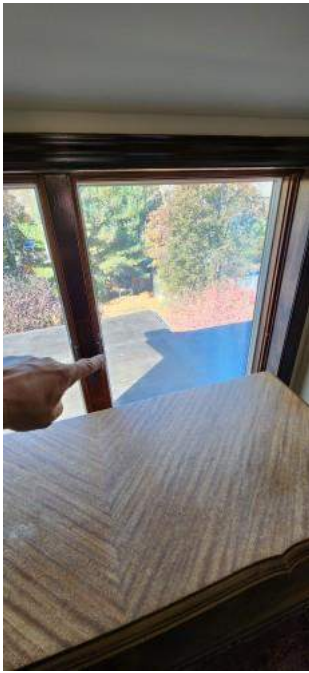
Broken thermal seal (foggy glass).

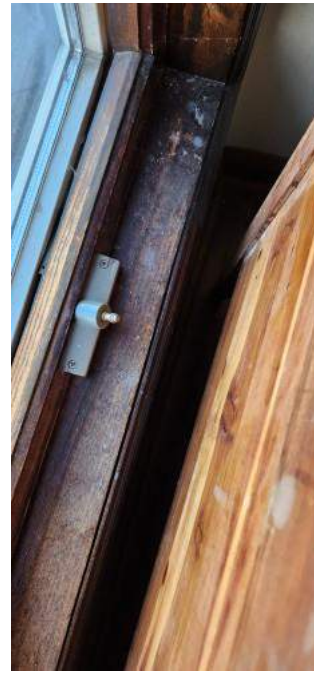
Missing casement crank.

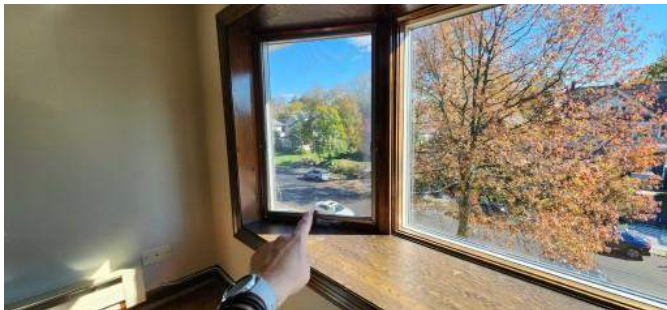
A casement window near the stairs would not open using normal force. Recommend adjustment/repair. It is suggested that a Qualified Handyman be contacted for further evaluation and repair.

Would not open.

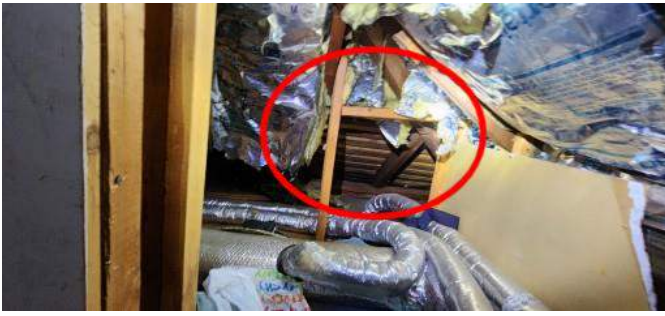
Insulation conditions of the floors and walls could not be assessed due to finishes. One open area of the rafters and floor had no insulation. Recommend installing batt insulation in this area. Knee walls around the attic can also be insulated if necessary. It is suggested that a Qualified Handyman be contacted for further evaluation and repair.

Missing insulation.

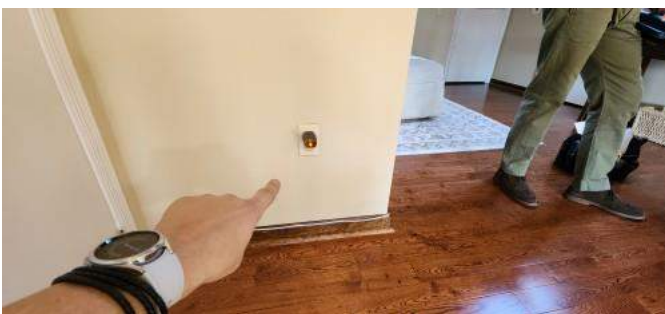
At the time of inspection two outlets in this room tested for missing ground. Missing ground is a common wiring problem that can usually be repaired by an electrician at the outlet. Recommend repair. It is suggested that a Licensed Electrical Contractor be contacted for further evaluation and repair.

Missing ground.

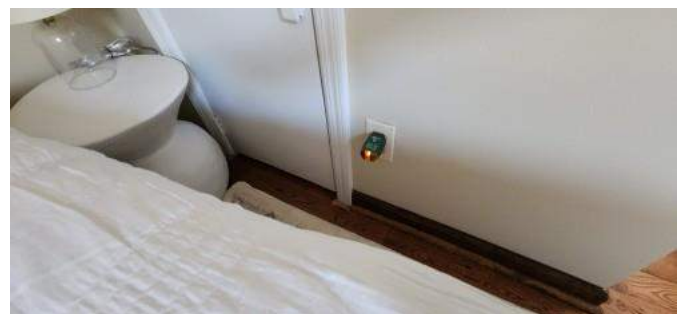
Missing ground.

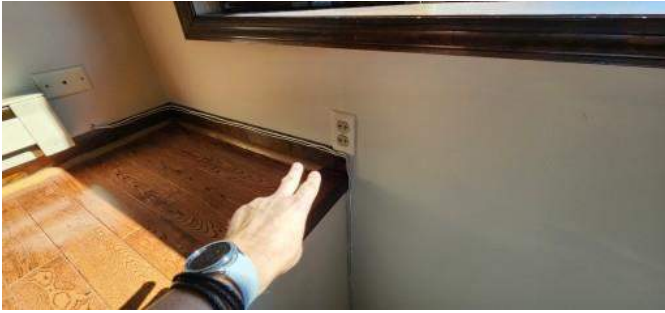
A two prong (non-grounded) outlet was observed. Although these were commonly used years ago, we recommend a licensed electrician upgrade to grounded three prong receptacles.

Ungrounded outlet at the top of the stairs.
