Home Inspection Report for:

**South Orange, NJ 07079**

Mike Leonard -- Mike Leonard Home Inspections LLC  
8 Highland Ave, Maplewood, NJ 07040  
Home Inspector License #24GI00196100  
973-801-0900 LeonardMG@gmail.com

May 30, 2026

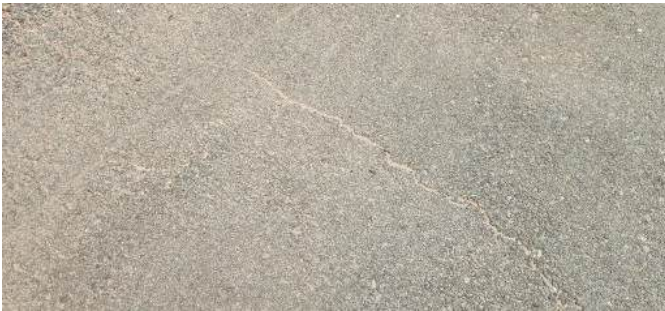
Common cracks were observed in the driveway at the time of inspection. Cracks allow water penetration, which leads to further deterioration during the freeze/thaw winter cycle. Sealants can extend the life of asphalt and are recommended every three to five years.

Common cracks.

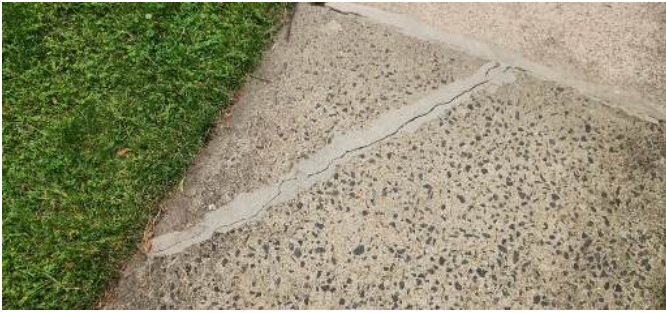
Common cracks were observed in the sidewalk surface at the time of inspection. It is recommended that these cracks be sealed to avoid water penetration. Water penetration leads to further deterioration through the freeze/thaw cycle of winter when trapped moisture expands. It is recommended that a Licensed Masonry Contractor be contacted for further evaluation and repair.

Common cracks.

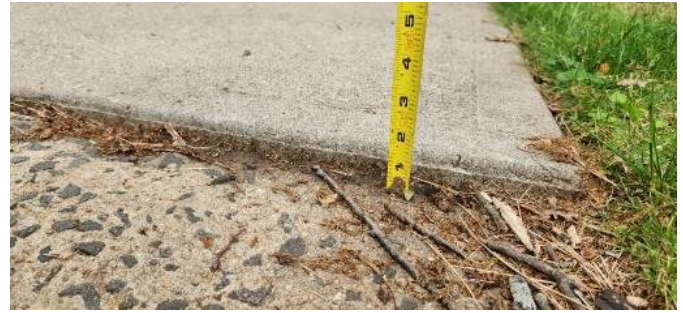
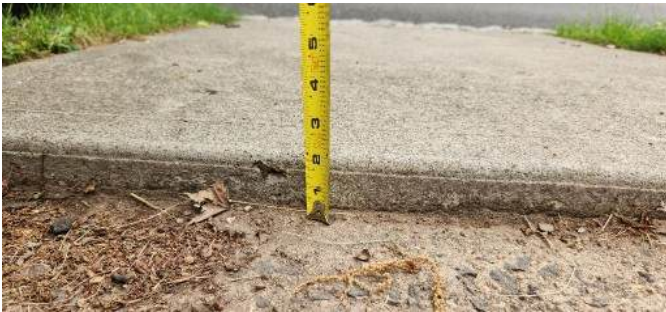
At the time of inspection, it was observed that in two areas, the concrete sections of the public sidewalk had settled or raised. This has created a height difference that is a tripping hazard. Further evaluation and repair by a Licensed Masonry Contractor is recommended.

Trip hazard.

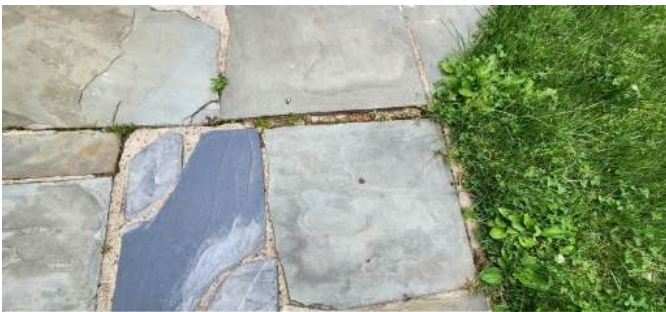
The walkway at the front entrance had missing mortar and cracked stones. Repair is recommended to avoid water intrusion. It is suggested that a Licensed Masonry Contractor be contacted for further evaluation and repair.

Missing/cracked mortar.

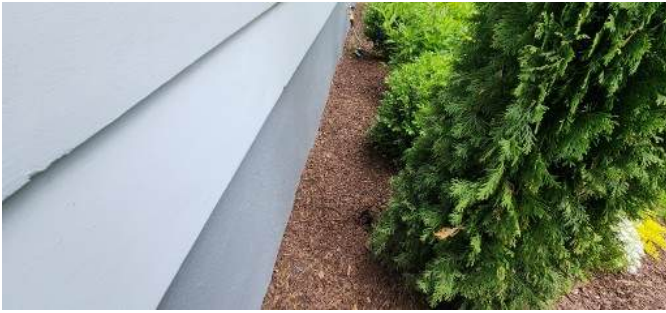
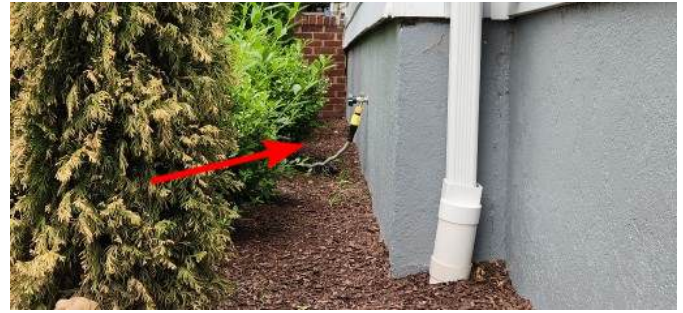
It was observed at the time of inspection that re-grading near the foundation was needed. Improving the grade to ensure all water drains away from the home's foundation is recommended. A 6" slope in the first 10 feet from the foundation is suggested. Failure to re-grade low-lying areas at the foundation can cause water seepage under slabs, into the basement/crawlspace, and/or cracks or movement in the foundation. The ground around the foundation should slope away from the house. It is recommended that a Licensed Landscaping Contractor be contacted for further evaluation and repair.

Improve grading at the front of the house.

Improve grading.

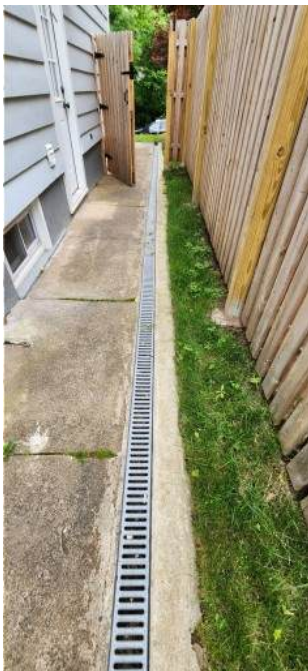
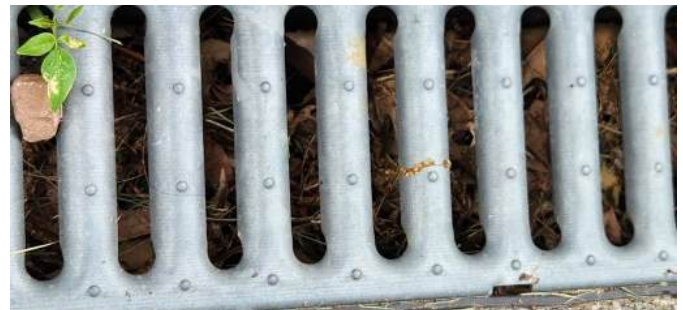
It was observed that there was a long drain on the left side of the house. Testing of exterior drains falls outside the scope of a home inspection. It was observed that the drain was clogged with debris. The covers did not appear to lift off easily. It is recommended that the sellers be asked how these grates are removed. Cleaning of the drain is needed. It is suggested that a Qualified Handyman be contacted for further evaluation and repair.

Needs cleaning.

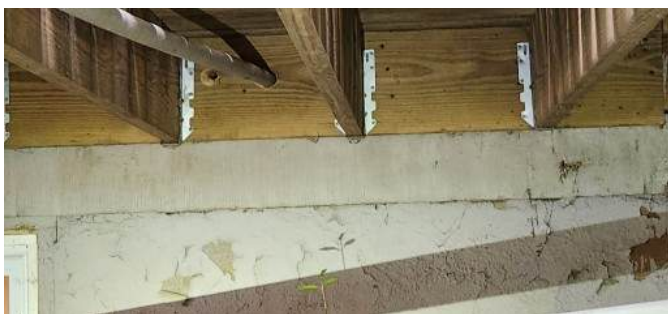
At the time of inspection, it was observed that the ledger board was attached to the house with nails; lag bolts offer more strength and are the preferred method of attachment. Most deck failures occur at the ledger board. The posts appeared to have footings but were covered with dirt. Direct wood-to-ground contact can lead to moisture-related deterioration. It is recommended that the dirt surrounding each post be cleared. It is suggested that a Qualified Handyman be contacted for further evaluation and repair.

Lag bolts are the preferred method of attachment.

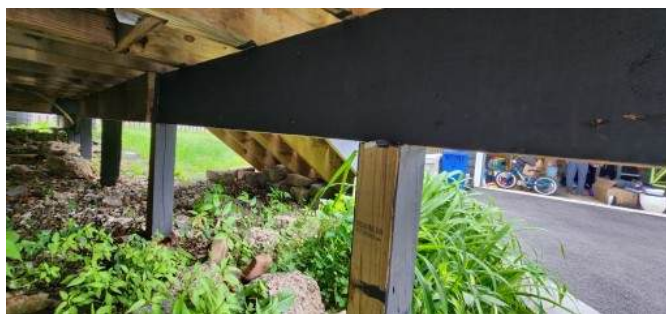
Posts in contact with the ground.

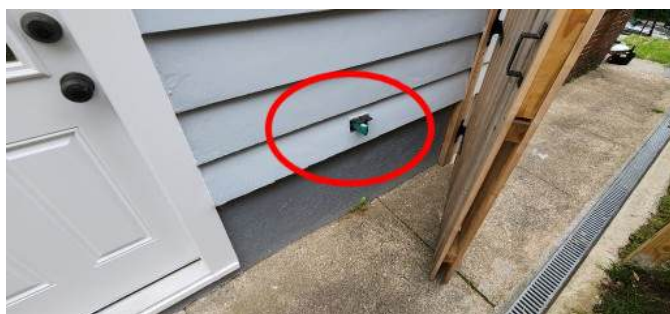
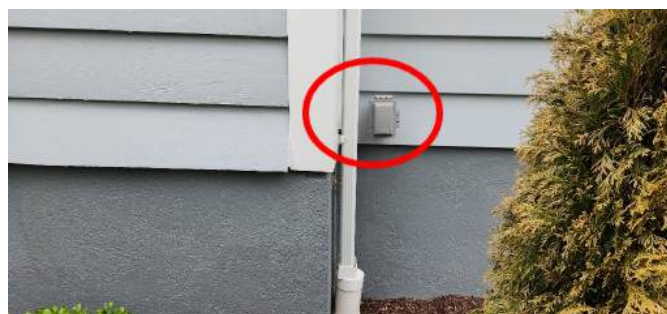
At the time of inspection, there were 2 dead GFCI outlets at the exterior of the house. Repair is needed. It is suggested that a Licensed Electrical Contractor be contacted for further evaluation and repair.

No power.

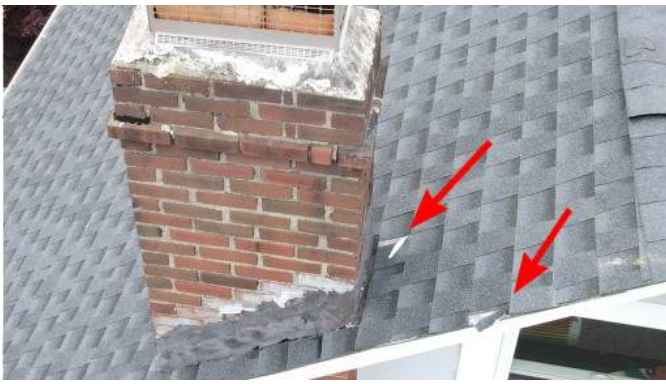
Should be sealed.

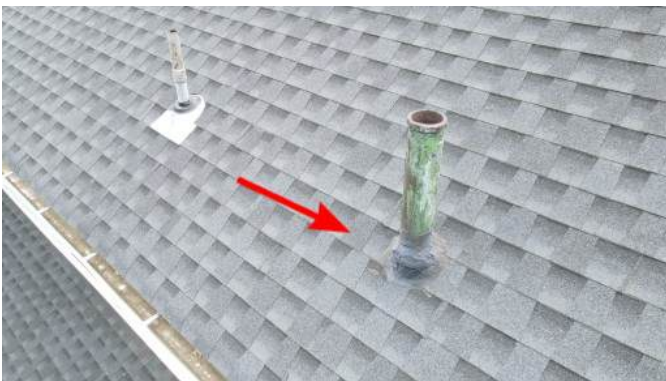
It was observed at the time of inspection that one of the roof penetrations was covered with tar. Tar is not a roofing product but is often used for sealing leaks. The metal boot flashing for the roof penetration was not visible. Further evaluation by a Licensed Roofing Contractor is recommended.

No boot flashing.

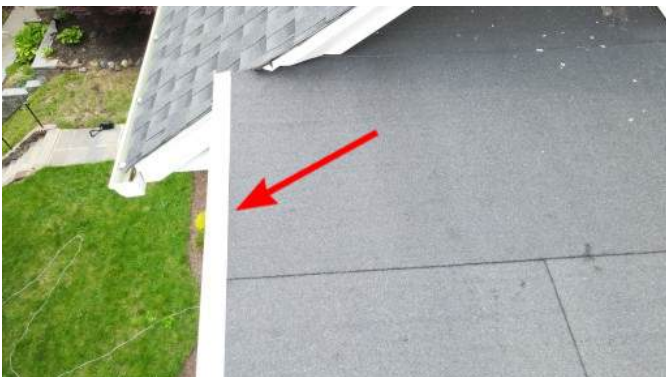
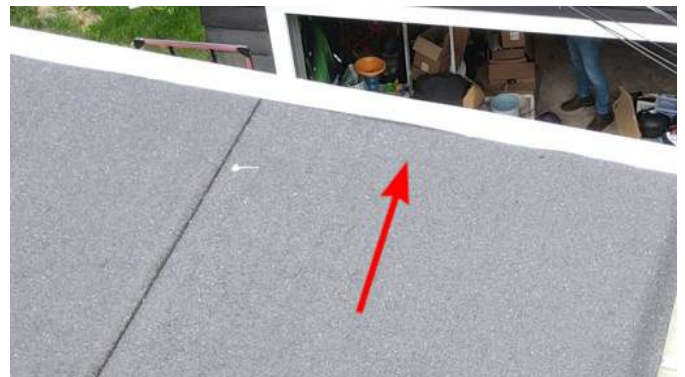
It was observed that drip edge flashing on the flat roof was not sealed at the time of inspection. The drip edge that overlaps the roof covering at the rake can be a place for water intrusion and should be sealed. It is suggested that a Licensed Roofing Contractor be contacted for further evaluation and repair.

Should be sealed.

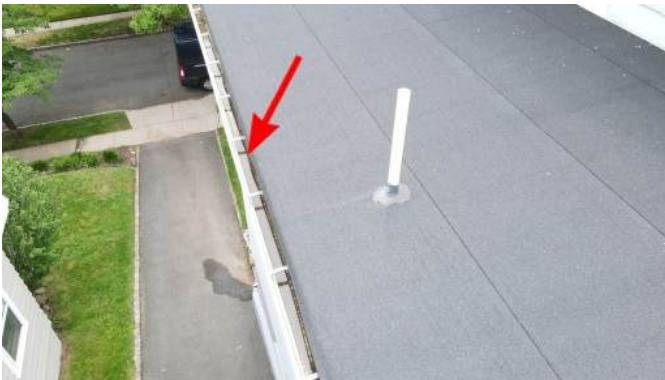
Water in the gutter.

Seasonal maintenance and cleaning of gutters and downspouts are recommended to ensure water is drained properly and does not damage the home. An immediate cleaning once the client has taken possession of the house is recommended.

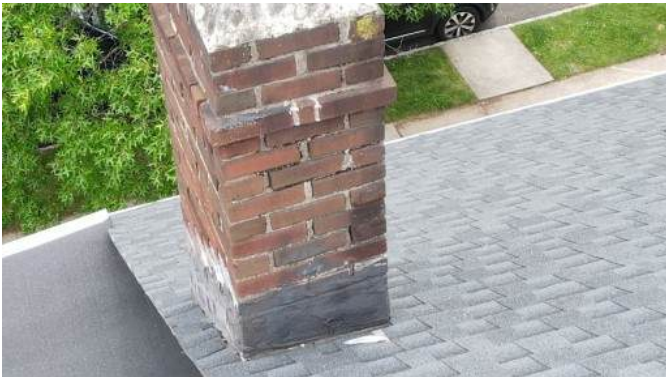
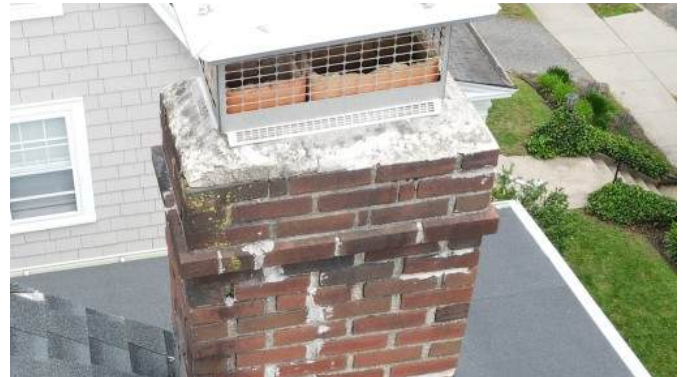
Cracked crown.

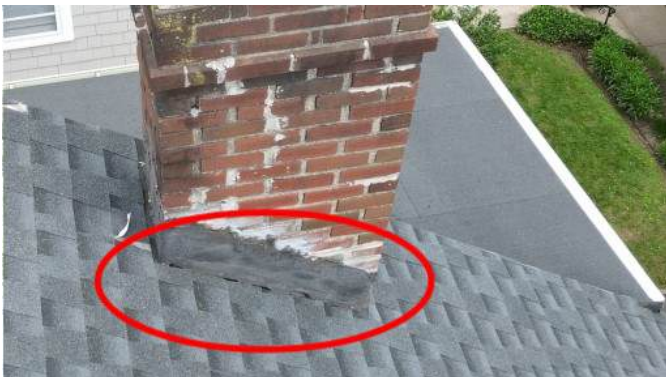
Does not appear to be sealed.

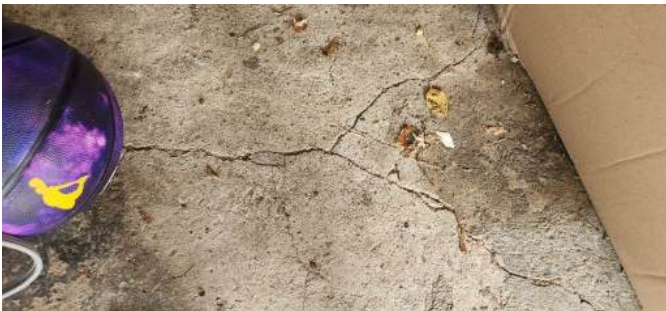
There was cracking in the concrete slab. This is typical, and no further action is recommended.

Typical cracking.

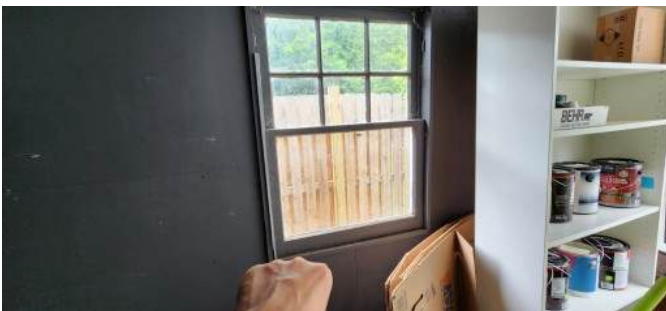
One or more windows in the garage would not open using normal force at the time of inspection. The windows may be stuck from lack of use or painted shut. Recommend further evaluation and repair by a Qualified Handyman.

Would not open.

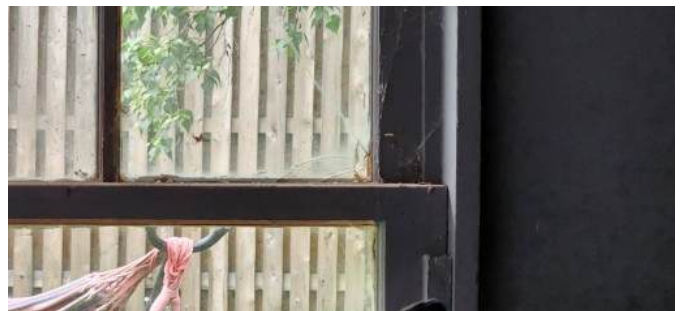
Cracked glass pane(s) were observed at the time of inspection. Recommend repair as broken glass can be a safety hazard. Recommend further evaluation and repair by a Licensed Contractor.

Broken glass.

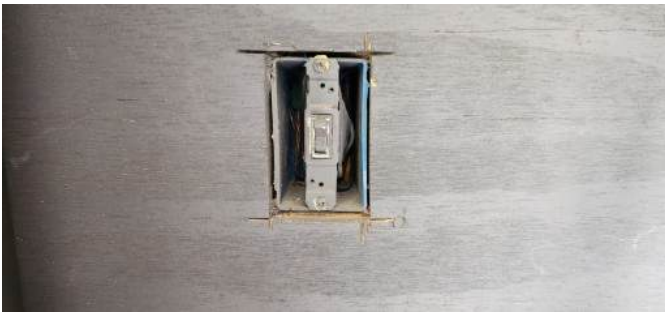
Missing receptacle or switch covers were observed. Recommend covers be installed for safety.

Cover plate needed.

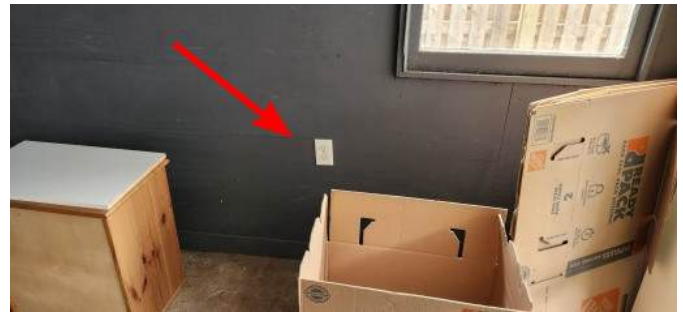
Outlets in the garage were not GFCI (Ground Fault Circuit Interrupter) outlets at the time of inspection. These are safety devices that detect changes in current. GFCI outlets are required to protect against electrical shock hazards, especially in areas where water or moisture may be present. Further evaluation and repair by a Licensed Electrical Contractor is recommended.

Not GFCI.

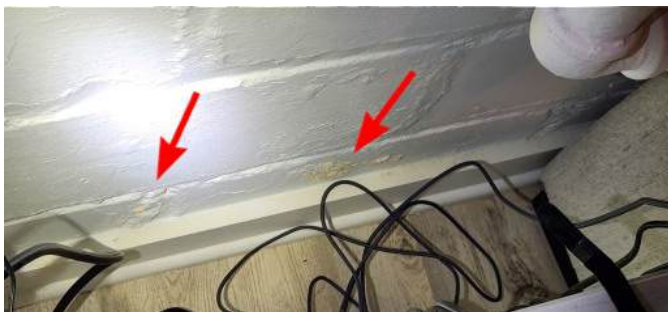
Efflorescence was observed on the foundation wall at the time of inspection. This is an indication that water has passed through the foundation wall. Efflorescence is a crystalline or powdery deposit of salts often visible on the surface of concrete, brick, stucco, or natural stone surfaces. It occurs when water leaves behind salt deposits on the masonry surface. Re-grading the exterior grounds so that water drains away from the house can reduce water seeping into the foundation.

Efflorescence.

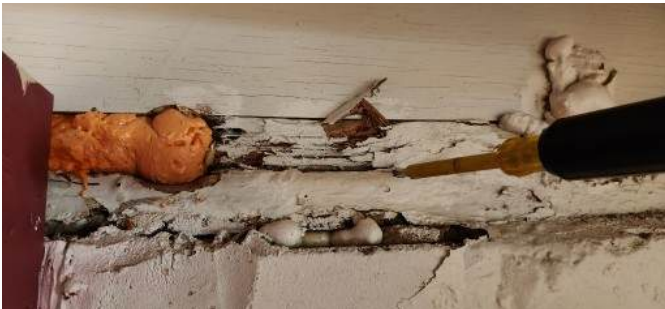
In the center of the basement, it was observed that the sill plate appeared to have dry rot. The sill plate is an important structural element that supports the flooring system. Further evaluation and repair by a Licensed Structural Contractor is recommended.

Dry rot of the sill plate.

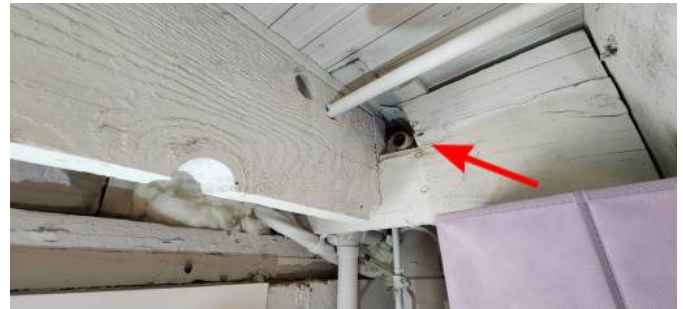
It was observed at the time of inspection that one or more of the floor joists were excessively notched. Notches should not exceed 1/6th of the joist depth and should not be placed in the center 3rd of the joist span. Some of the floor joists were notched for installation or cut to allow passage of pipes or wire. Although this may have been common practice at the time of installation, today's construction limits cuts in floor joists and support framing. Notches and cuts that are too large weaken this structural part of the flooring system. Further evaluation and repair by a Licensed Structural Contractor is recommended.

Large notch in laundry room.

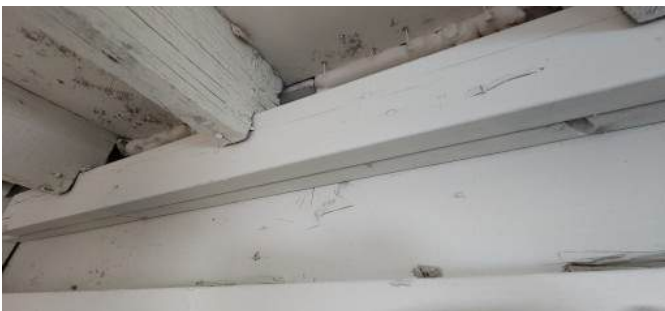
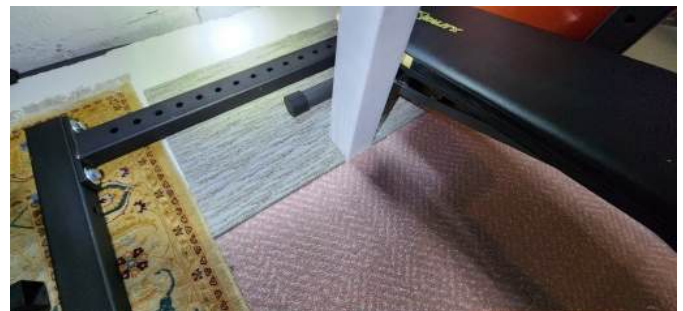
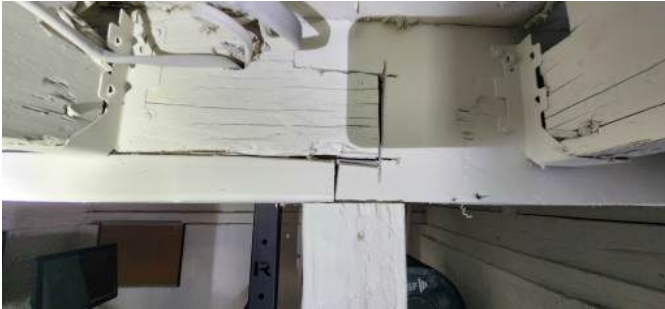
In the gym area, framing appeared to be undersized. A wooden column was sitting on the concrete slab and was not secured. Beams have been notched and weakened. Improper and inadequate support of the joists was observed. Further evaluation and repair by a Licensed Structural Engineer is recommended. PRIOR TO CLOSE

Joists are resting on a 2"x4" nailed to a 2"x4". (gym area)

Wood support is sitting on the floor. (gym area)

Beams have been notched and weakened. (gym area)

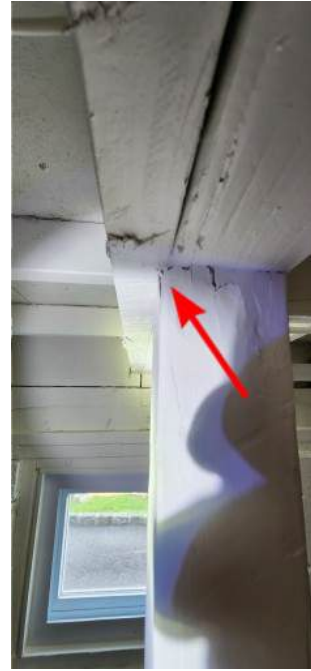
No support.

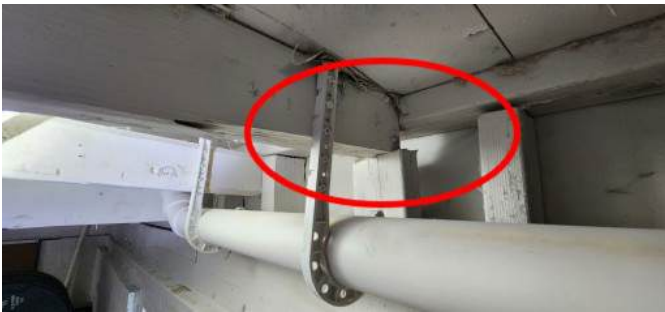
No joist support.

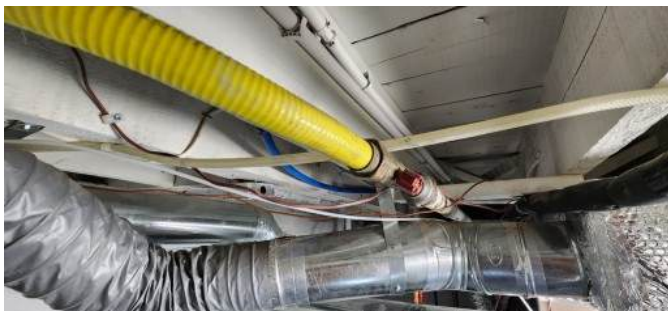
The home contains CSST (corrugated stainless steel tubing) gas piping that is not properly bonded. Current safety standards require CSST to be bonded to the home's electrical grounding system to reduce the risk of damage from lightning-induced electrical surges. Recommend evaluation and proper bonding by a Licensed Electrical Contractor.

Not bonded.

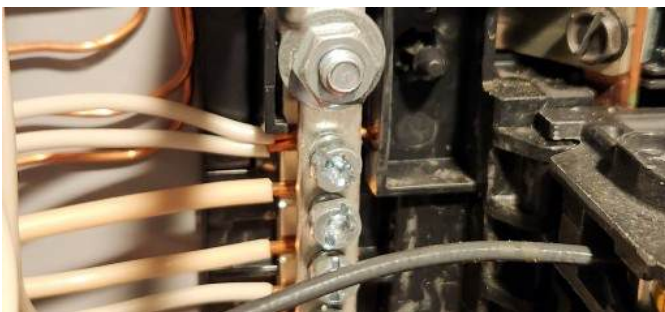
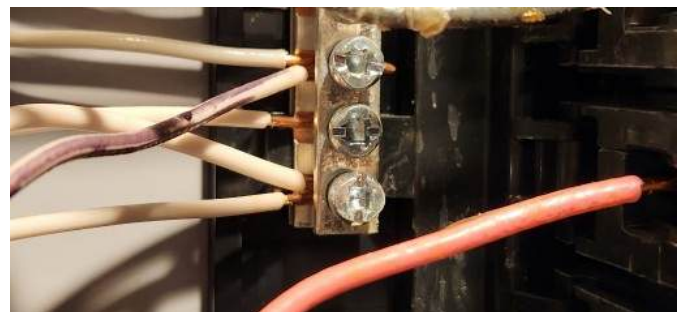
At the time of inspection, there was more than one neutral wire under each screw on the neutral bar. This can cause the wires to not be tightened down properly, which can lead to arcing and a possible fire. Recommend further evaluation by a Licensed Electrical Contractor.

Multiple neutrals under one screw.

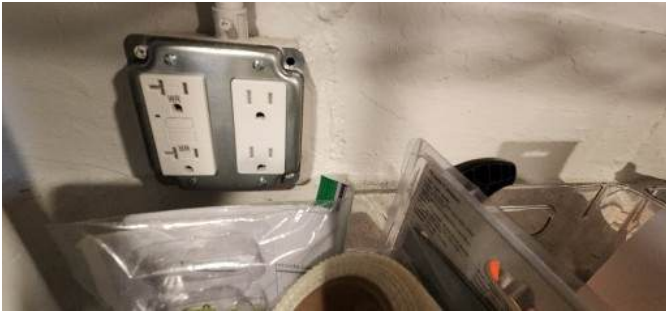
At the time of inspection, the outlet on the right tripped the GFCI next to it every time something was plugged into it. It is suggested that a Licensed Electrical Contractor be contacted for further evaluation and repair.

The right-side outlet was unusable.

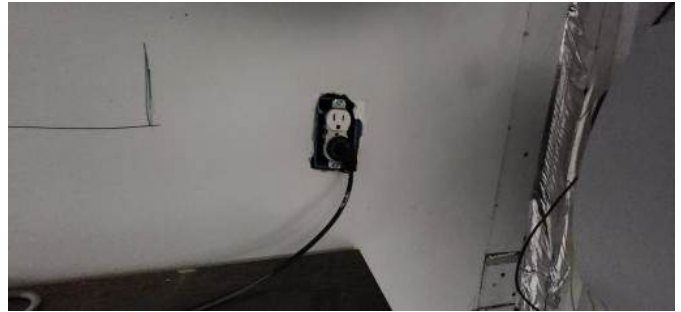
At the time of inspection, an outlet in the basement was not a GFCI (Ground Fault Circuit Interrupter) with a reset button. GFCI outlets are installed for safety. They detect changes in current and shut the power off if changes occur. Even if this outlet is GFCI-protected from the breaker in the electrical panel or from another outlet, a new one with a reset is recommended. It is suggested that a Licensed Electrical Contractor be contacted for further evaluation and repair.

Outlet should be a GFCI.

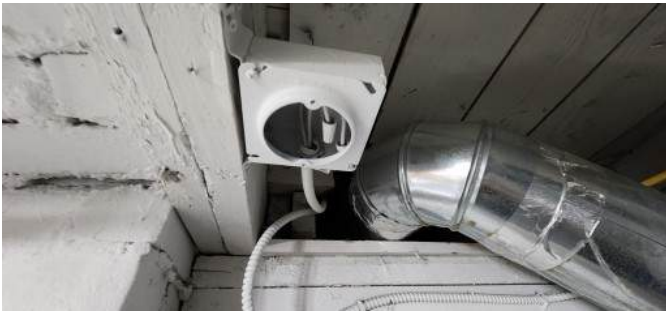
Cover needed.

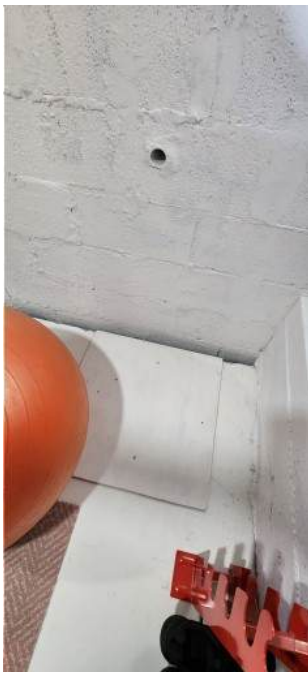
No sump pump/pit was observed in the house at the time of inspection. It appeared there had been one in the gym area but the pit was covered and there was no piping for a pump.

Appeared to be a covered sump pit.

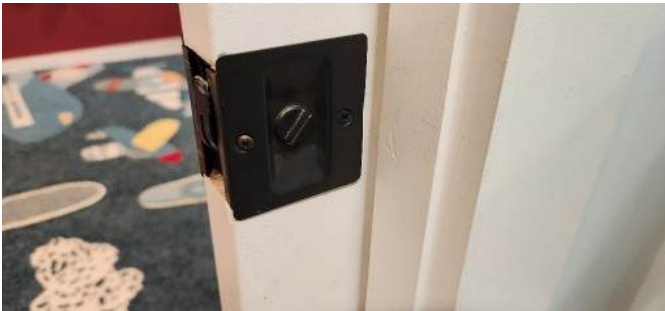
At the time of inspection the door lock would not engage. It is suggested that a Qualified Handyman be contacted for further evaluation and repair.

Lock would not engage.

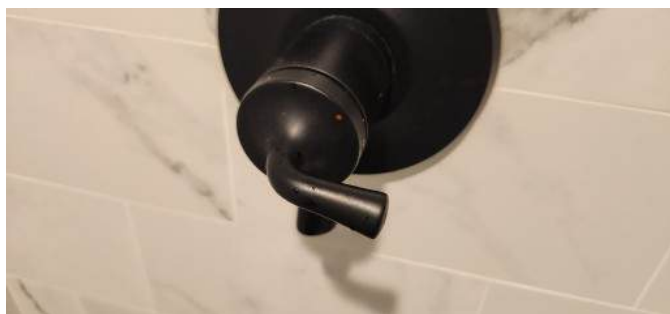
At the time of inspection, the faucet handle (temp control) was loose. Recommend repair. It is suggested that a Qualified Handyman be contacted for further evaluation and repair.

The faucet handle was loose.

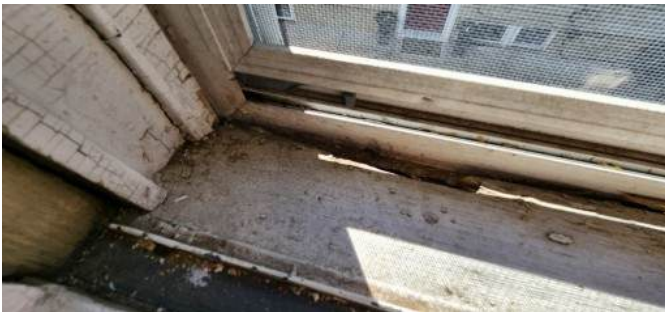
Moisture damage.

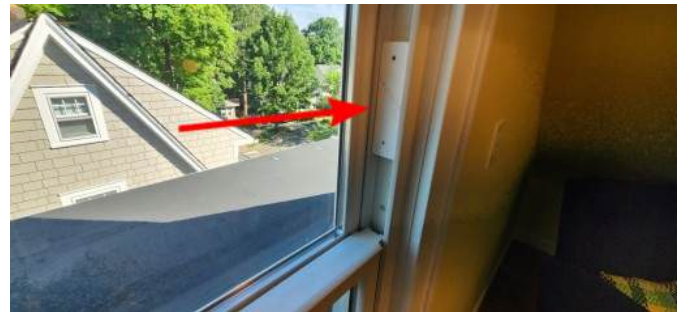
A window on the 3rd floor was prevented from opening due to a wooden block fastened to the frame. This prevents escape to the roof in the case of an emergency. Removal is needed. It is suggested that a Qualified Handyman be contacted for further evaluation and repair.

Remove.

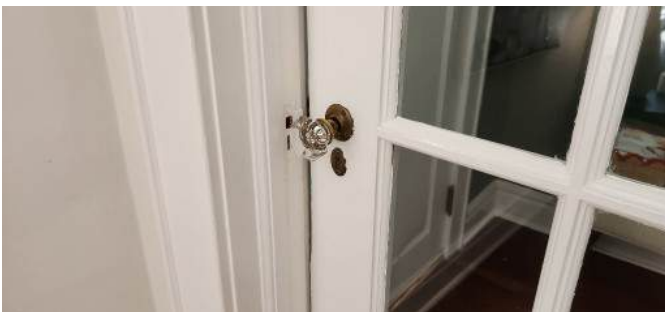
It was observed at the time of inspection that an interior door didn't latch properly at the time of inspection. Recommend repair/adjustment by a Qualified Handyman as needed.

Would not latch.

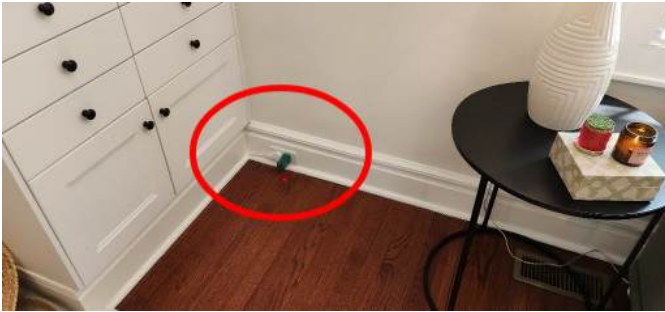
is when a three-pronged outlet is not connected to the home's grounding system. This is unsafe because if a fault were to happen, the surge could damage equipment or people rather than routing to the ground. This is a common wiring mistake that can usually be repaired at the outlet. It is recommended that a Licensed Electrical Contractor be contacted for further evaluation and repair.

Missing ground.

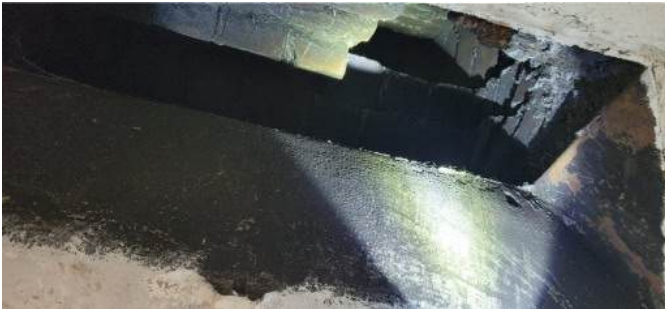
It was observed that there was no damper in the fireplace at the time of inspection. This allows heated air in the interior spaces to escape up the chimney. It is suggested that a Licensed Chimney Contractor be contacted for further evaluation and repair.

No damper.

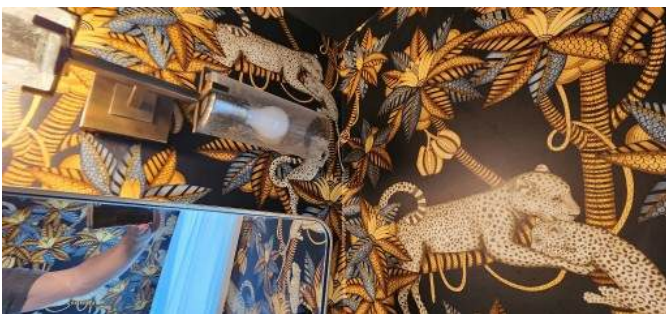
At the time of inspection a light in this room did not function. Recommend changing the bulb and re-testing. If the problem persists it is recommended a Licensed Electrical Contractor be contacted for further evaluation and repair.

Bulb burned out.

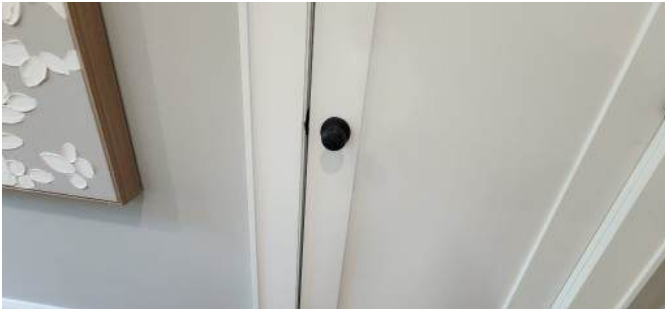
It was observed at the time of inspection that the bedroom door didn't latch properly at the time of inspection. Recommend repair/adjustment by a Qualified Handyman as needed.

Would not latch.

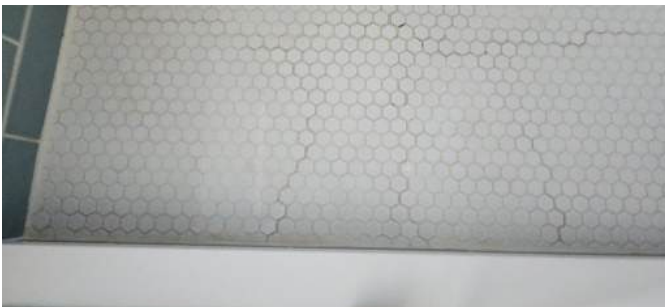
The shower enclosure, faucet, and drain appeared to be in serviceable condition at the time of inspection. Light cracking was observed in some of the shower floor grout. Repair is recommended. It is suggested that a Licensed Contractor be contacted for further evaluation and repair.

Grout repair is needed.

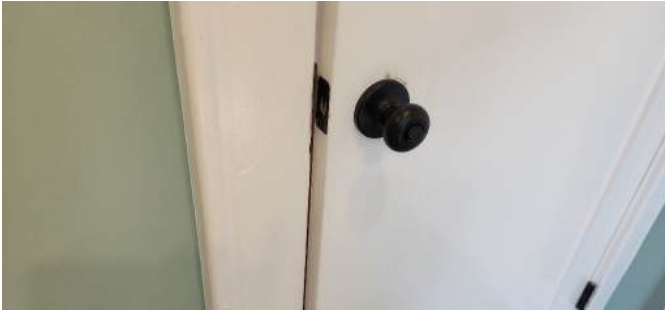
It was observed at the time of inspection that the bedroom door didn't latch properly at the time of inspection. Recommend repair/adjustment by a Qualified Handyman as needed.

Would not latch.

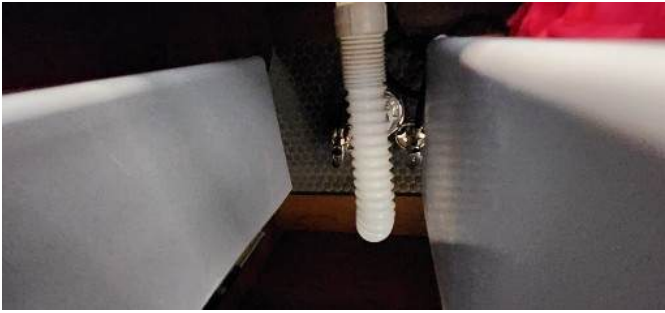
At the time of inspection, there was improper piping at the drain tailpiece. Flexible piping is a DIY solution that is more prone to leaks and clogs. Rigid piping is needed. It is suggested that a Licensed Plumbing Contractor be contacted for further evaluation and repair.

Incorrect piping.
