Home Inspection Report for:

Mike Leonard -- Mike Leonard Home Inspections LLC
8 Highland Ave, Maplewood, NJ 07040
Home Inspector License #24GI00196100
973-801-0900 LeonardMG@gmail.com

November 3, 2023

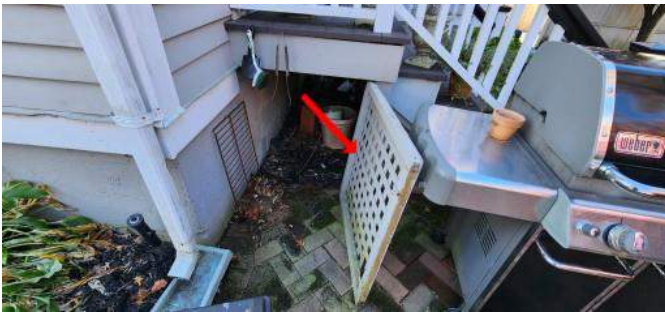
Entry door not attached.

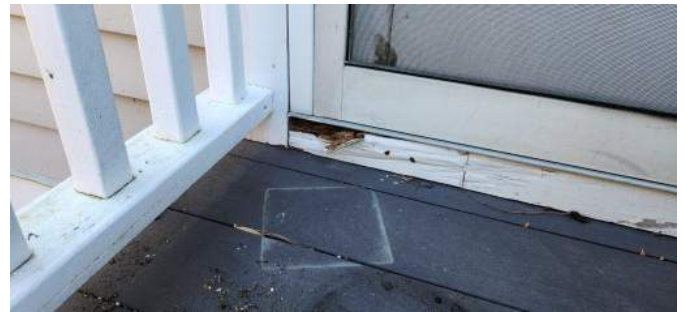
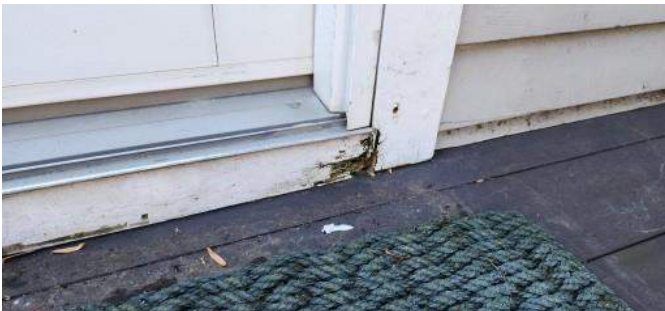
It was observed that the board under the rear door sill was water damaged and rotten. Recommend replacement. It is suggested that a Licensed Contractor or Qualified Handyman be contacted for further evaluation and repair.

Board under the door sill was rotten.

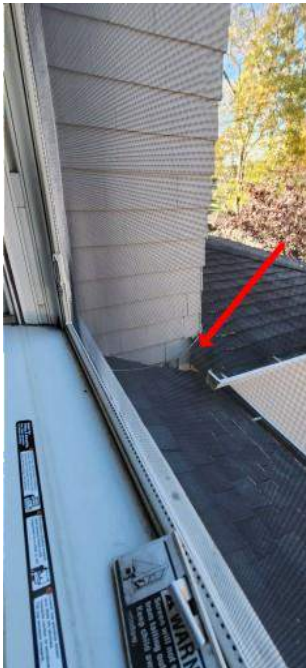
At the time of inspection it was observed a wood shingle was missing at the rear of the house. Recommend repair to avoid water penetration. Existing conditions behind the shingles is unknown. It is suggested that a Licensed Contractor or Qualified Handyman be contacted for further evaluation and repair. A roofer can also make this repair.

Missing wood shingle. (rear of house)

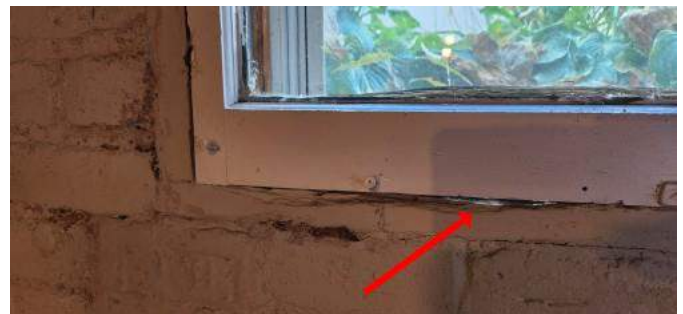
Nailed shut. Weather-stripping needed to seal drafts.

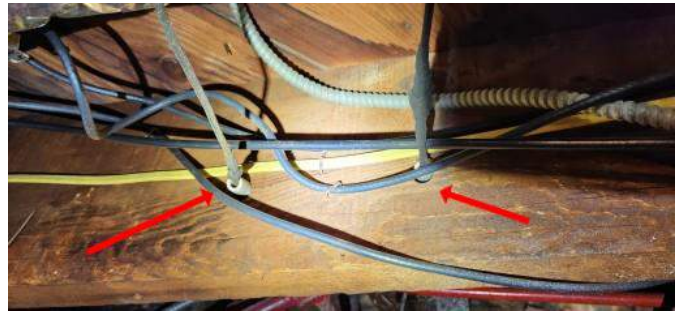
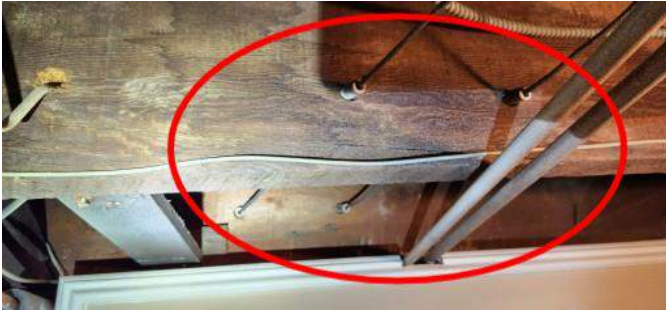
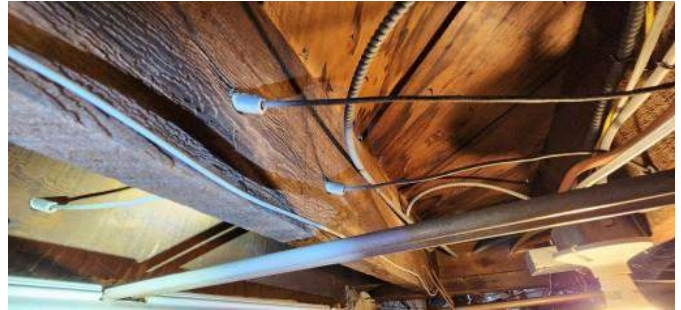
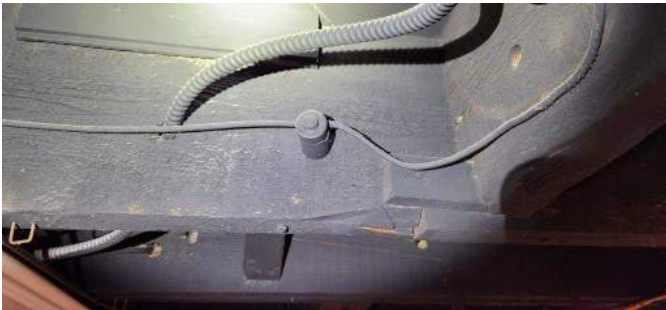
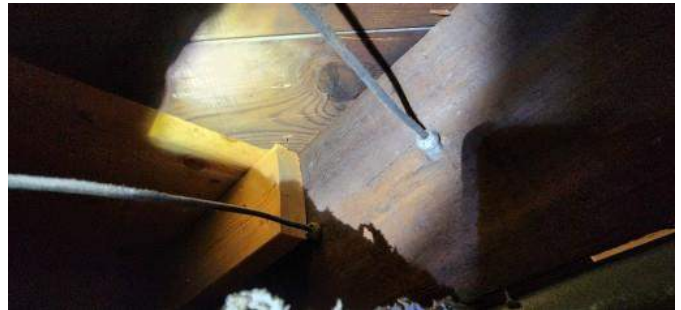
Knob and tube wiring was observed at the time of inspection. The accessible wires were tested with a voltage detector and were found to be live. There was approximately 30 feet of active wiring visible. Although installation and usage of this wiring was typical at the time of installation, today's construction no longer uses this out dated system. Since this older wiring exists with open splices and limited wire insulation, client is advised to consult with a licensed electrician (prior to close) for further information on this wiring and / or upgrading. Client should also contact their insurer (prior to close) to inquire whether the presence of this wiring affects home insurance coverage. It is suggested that a Licensed Electrical Contractor be contacted for further evaluation and repair.

Knob and tube.

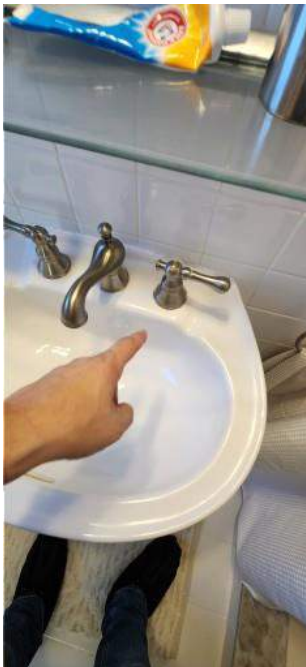
It was observed at the time of inspection that the hot and cold faucets were reversed. The faucet on the right side was difficult to turn. Recommend repair. It is suggested that a Licensed Plumbing Contractor be contacted for further evaluation and repair.

Hard to turn.

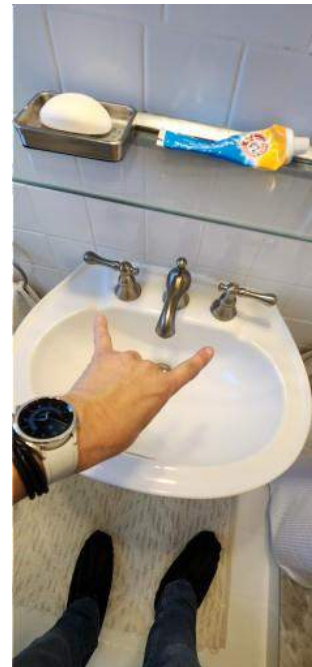
Hot and cold reversed.

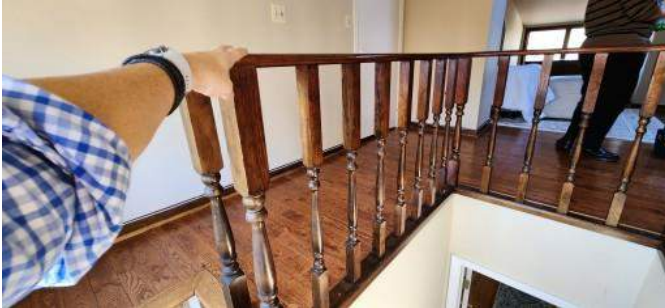
At the time of inspection it was observed that the guardrail around the stairs was loose. Part of the opening was unprotected with no guardrail. The gap between the balusters was wider than 4" which could allow a child to stick their head into the space. Recommend repair/replacement for safety.

Loose guardrail.

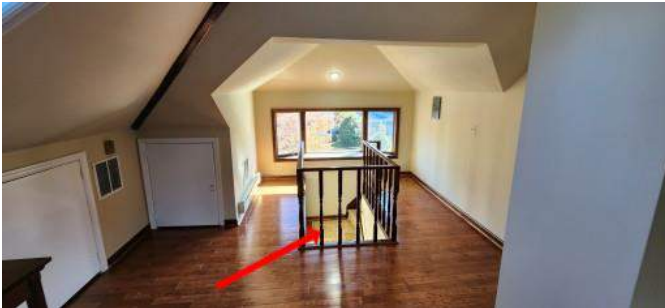
Loose guardrail. Balusters too far apart.
