Home Inspection Report for:

**South Orange, NJ 07079**

Mike Leonard -- Mike Leonard Home Inspections LLC  
8 Highland Ave, Maplewood, NJ 07040  
Home Inspector License #24GI00196100  
973-801-0900 LeonardMG@gmail.com

May 30, 2026

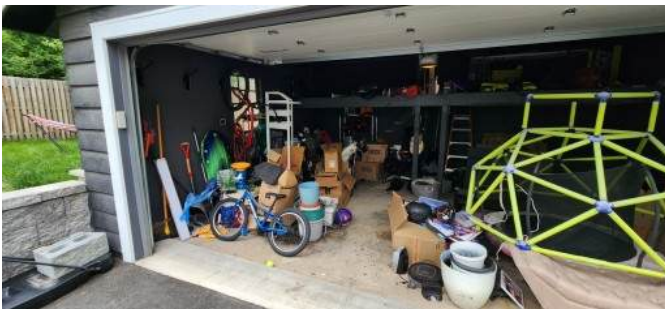
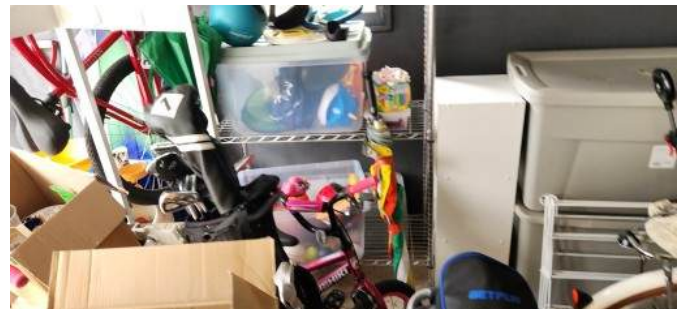
#### 4.12) Limitations

Not all areas of the garage were visible due to the homeowner's belongings.

Limitations.
